Windstorm Mitigation Report

Raintree Village Condominium

Clearwater, FL

As of 02-13-2026 | FPAT File# MUD2625436

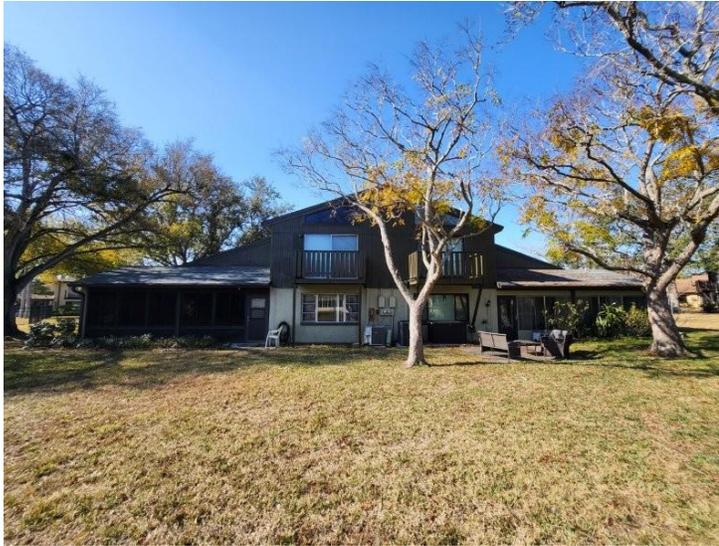
Roof Permit
Information

- 2. Roof Covering:** **FBC Equivalent**
Comments: The roof covering was replaced in 2020. The roof permit was confirmed and the permit number is BCP2020-070484. This roof was verified as meeting the building code requirements outlined on the mitigation affidavit.

Record BCP2020-070484:
Building - Construction Permit
Record Status: Completed

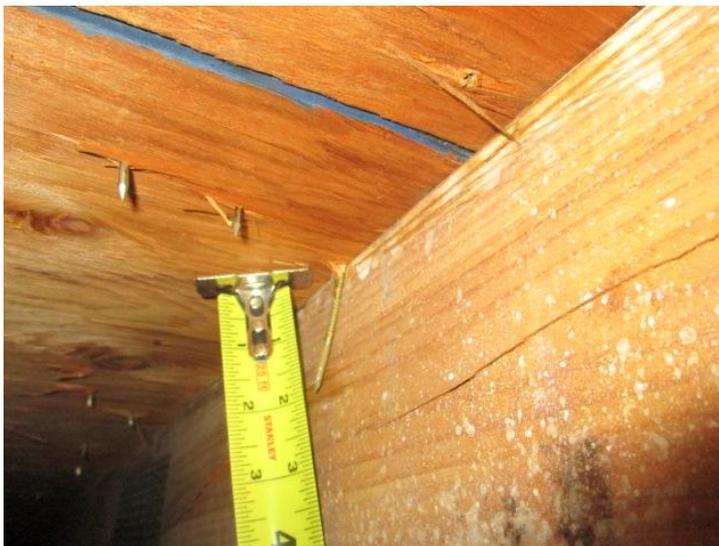
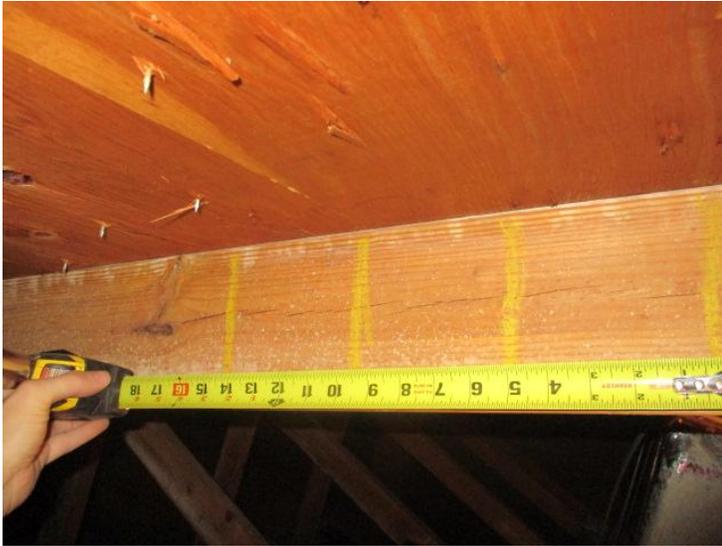
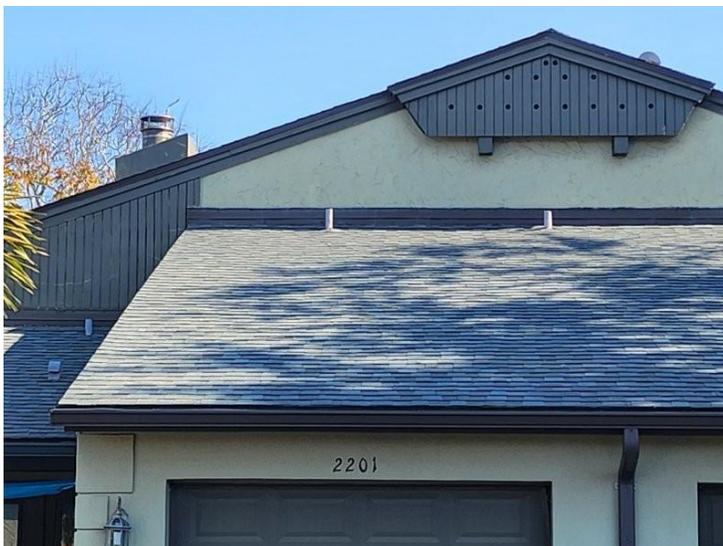
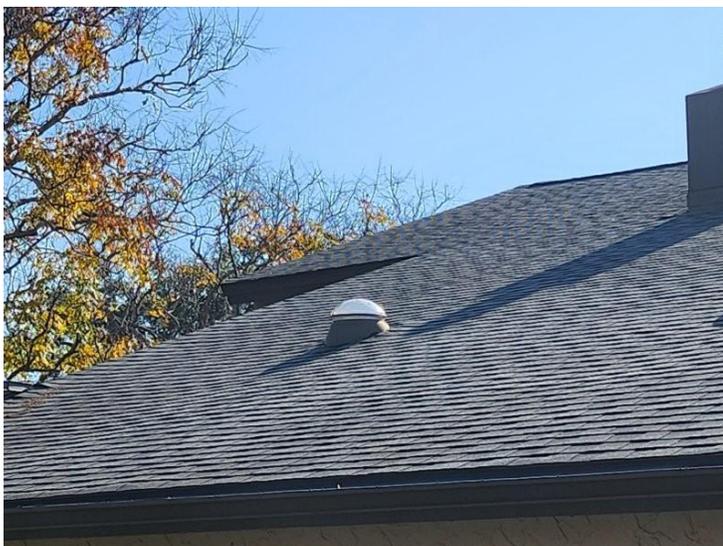
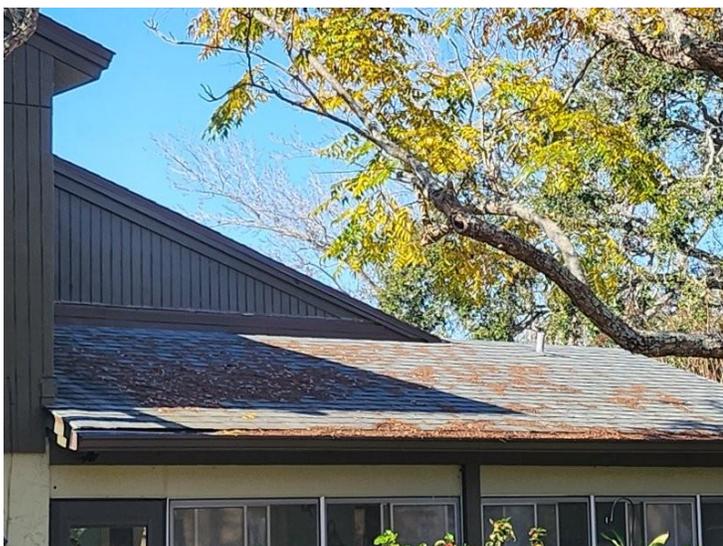
Roof Construction

- 3. Roof Deck Attachment:** **Level C**
Comments: Inspection verified 1/2" plywood roof deck attached with 8d nails at a minimum 6" on the edge & 6" in the field.

- 4. Roof to Wall Attachment:** **Clips**
Comments: Inspection verified hurricane clips fastened with a minimum of three nails.
- 5. Roof Geometry:** **Other Roof**
Comments: Inspection verified a gable roof shape.

- 6. SWR:** **Yes**
Comments: SWR was verified at time of inspection. The Secondary Water Resistance verified is a self-adhering peel and stick.
- 7. Opening Protection:** **None or Some Glazed Openings**
Comments: Inspection verified some impact rated opening protection. Not all glazed openings were protected with impact resistant coverings.

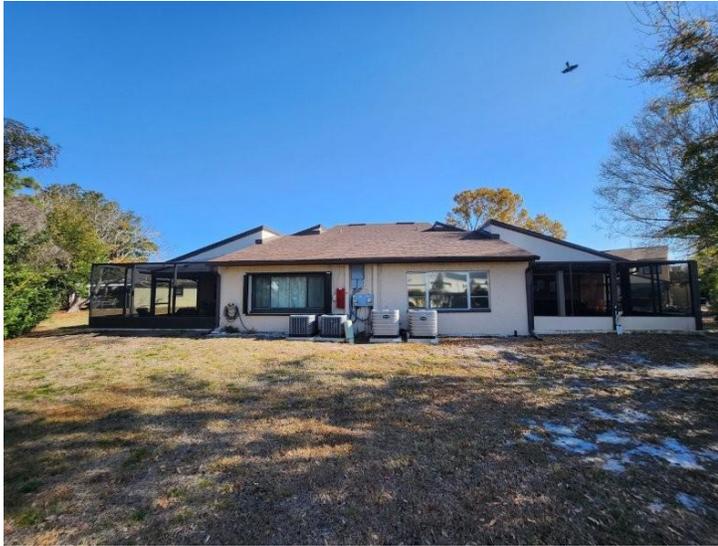
Roof Permit
Information

- 2. Roof Covering:** **FBC Equivalent**
Comments: The roof covering was replaced in 2020. The roof permit was confirmed and the permit number is BCP2020-070709. This roof was verified as meeting the building code requirements outlined on the mitigation affidavit.

Record BCP2020-070709:
Building - Construction Permit
Record Status: Completed

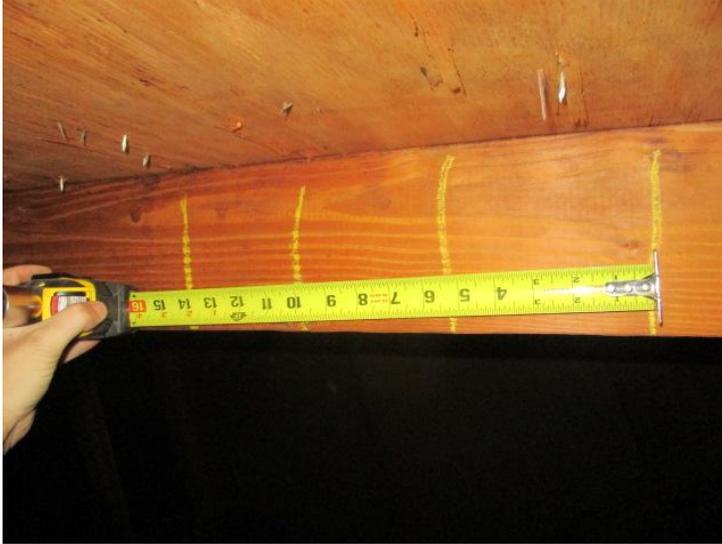
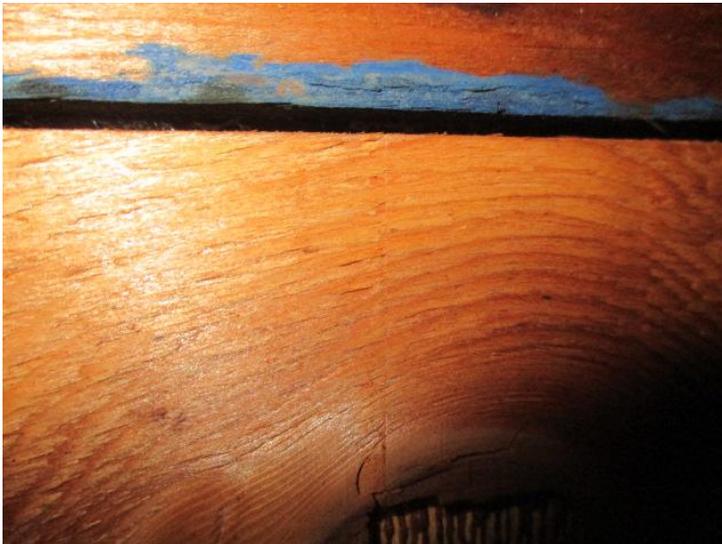
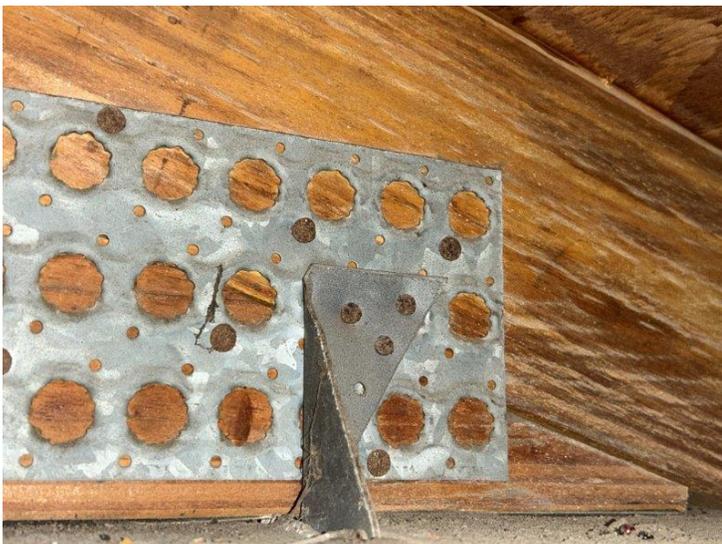
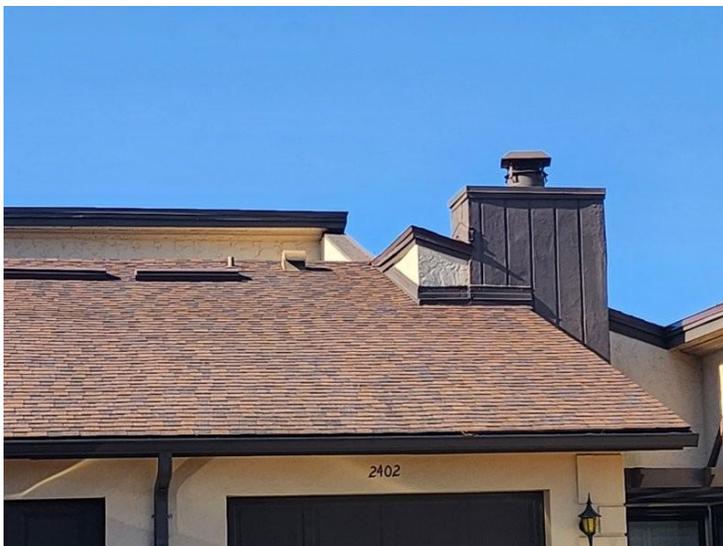
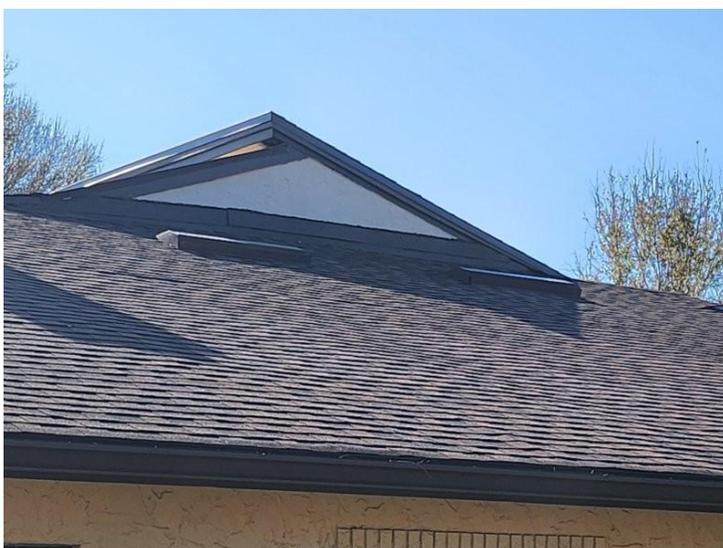
Roof Construction

- 3. Roof Deck Attachment:** **Level C**
Comments: Inspection verified 1/2" plywood roof deck attached with 8d nails at a minimum 6" on the edge & 6" in the field.

- 4. Roof to Wall Attachment:** **Clips**
Comments: Inspection verified hurricane clips fastened with a minimum of three nails.
- 5. Roof Geometry:** **Other Roof**
Comments: Inspection verified a gable roof shape.

- 6. SWR:** **Yes**
Comments: SWR was verified at time of inspection. The Secondary Water Resistance verified is a self-adhering peel and stick.
- 7. Opening Protection:** **None or Some Glazed Openings**
Comments: Inspection verified some impact rated opening protection. Not all glazed openings were protected with impact resistant coverings.
