## Windstorm Mitigation Report (OIR-B1-1802)

Raintree Village Condominium, Inc.  
2101 Sunset Point Rd, Units 2401-2402  
Clearwater, FL 33765

As of 02-13-2026 | FPAT File# MUD2625436

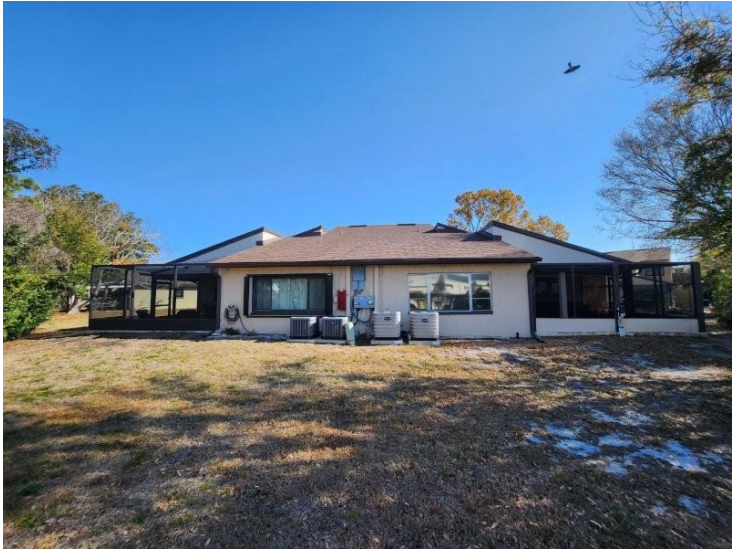
Roof Permit  
Information

Record BCP2020-070709:  
Building - Construction Permit  
Record Status: Completed

| <b>Project Name</b><br>Rainforest 2400<br>Online Permit - Tear off and re-roof entire building 2401<br>and 2402. 5122 sq. feet and stick Contaminated Shingles | <b>Property Owner Info:</b><br>LEWIS P BARONE *<br>29 LISMORE GRN<br>ROCHESTER NY 14617-1464 |

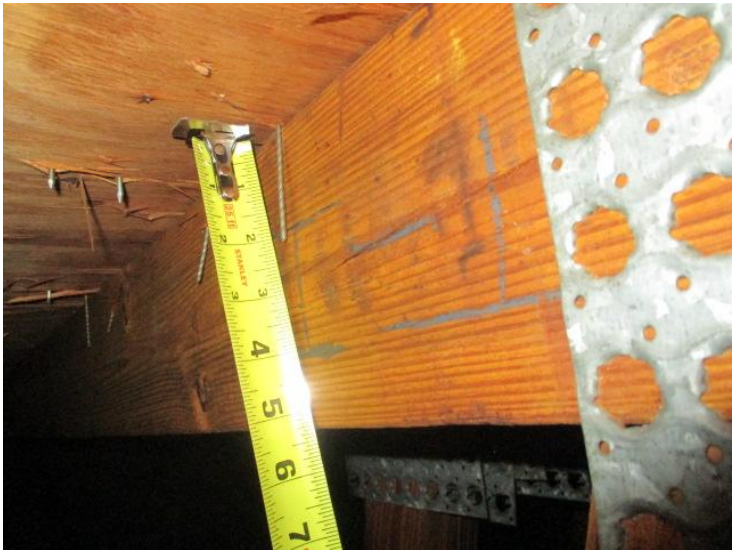
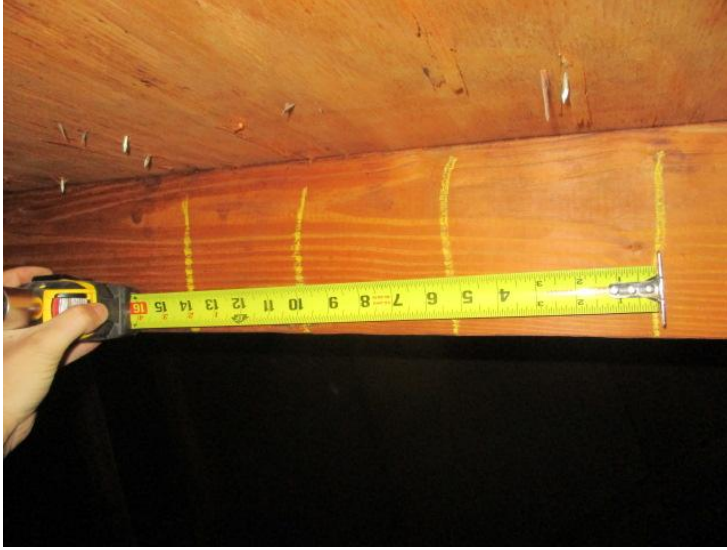
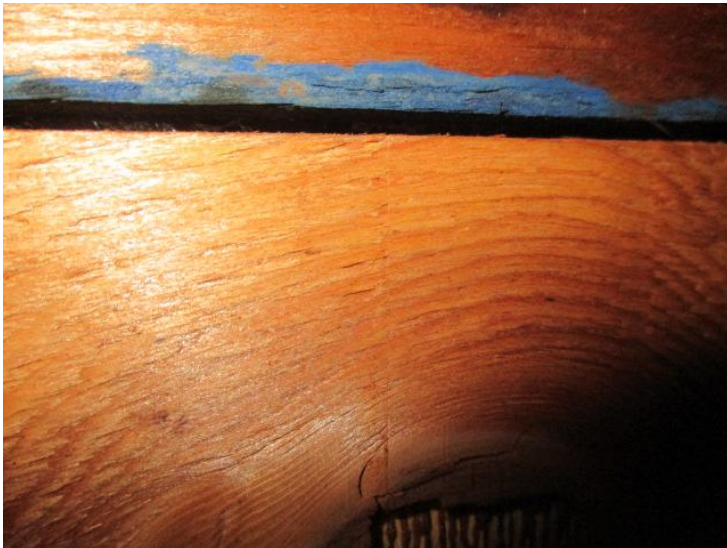
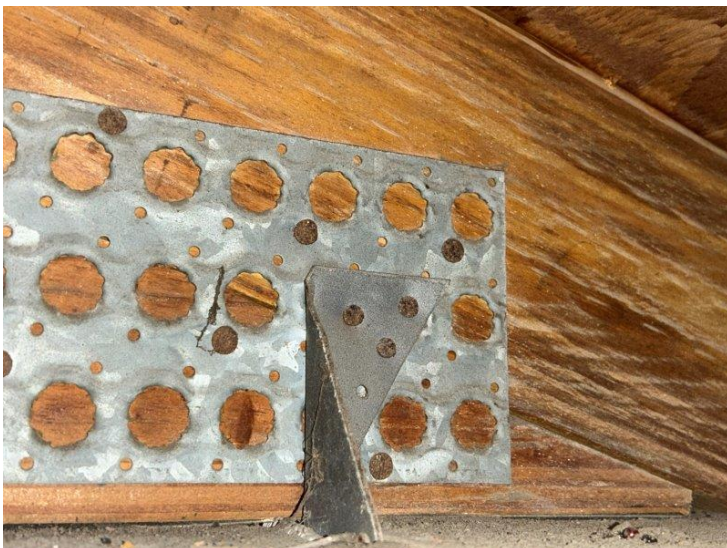
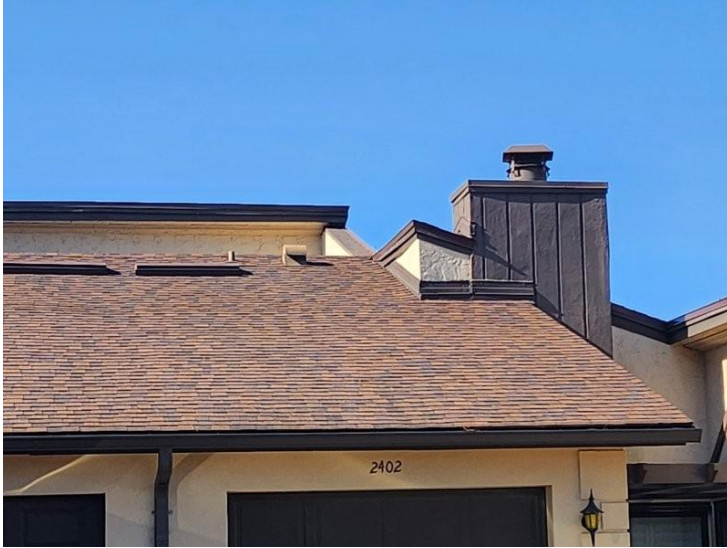
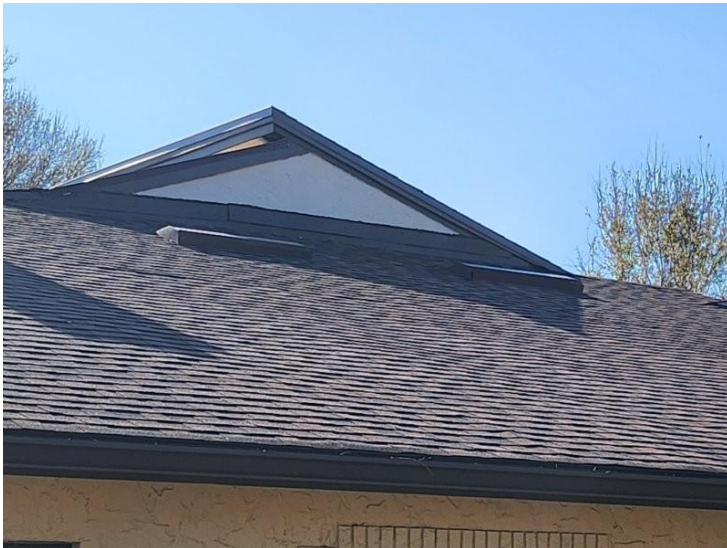
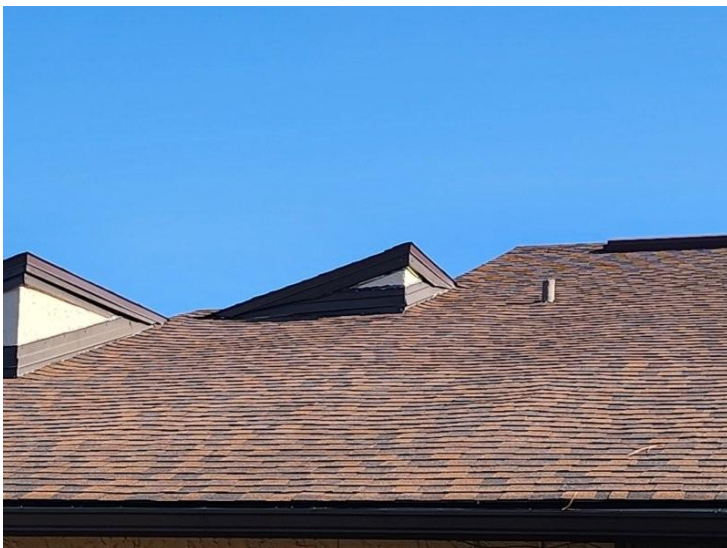
Roof Construction

| <b>3. Roof Deck Attachment:</b><br>Comments: | <b>Level C</b><br>Inspection verified 1/2" plywood roof deck attached with 8d nails at a minimum 6" on the edge & 6" in the field. |
| <b>4. Roof to Wall Attachment:</b><br>Comments: | <b>Clips</b><br>Inspection verified hurricane clips fastened with a minimum of three nails. |
| <b>5. Roof Geometry:</b><br>Comments: | <b>Other Roof</b><br>Inspection verified a gable roof shape. |
| <b>6. SWR:</b><br>Comments: | <b>Yes</b><br>SWR was verified at time of inspection. The Secondary Water Resistance verified is a self-adhering peel and stick. |
