## Windstorm Mitigation Report (OIR-B1-1802)

Raintree Village Condominium, Inc.

2101 Sunset Pointe Rd, Building 100, Units 101-106

As of 5/8/2023 | FPAT File# MUD2318333

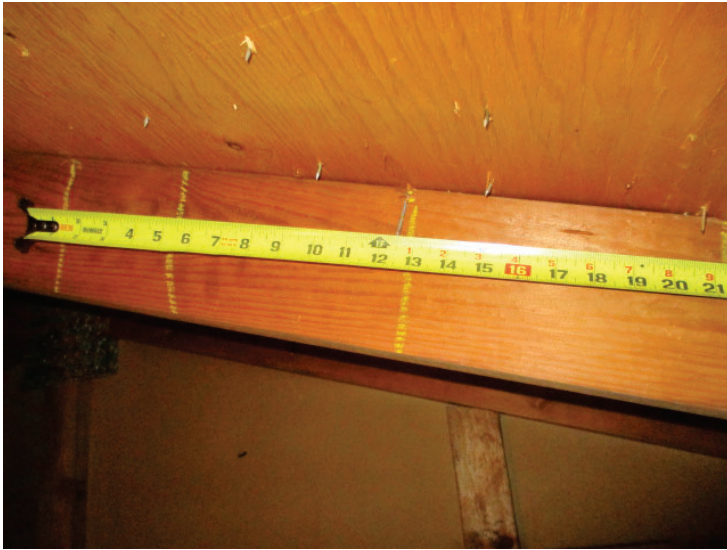
Roof Construction

| <b>3. Roof Deck Attachment:</b><br>Comments: | <b>Level B</b><br>Inspection verified 1/2" plywood roof deck attached with 8d nails at a minimum of 6" on the edge & 12" in the field. |
| <b>4. Roof to Wall Attachment:</b><br>Comments: | <b>Toe Nails</b><br>Inspection verified hurricane clips fastened with less than three nails. |
| <b>5. Roof Geometry:</b><br>Comments: | <b>Other Roof</b><br>Inspection verified a gable roof shape. |
| <b>6. SWR:</b><br>Comments: | <b>Yes</b><br>SWR was verified at time of inspection. The Secondary Water Resistance verified is a self-adhering peel and stick. |
