Windstorm Mitigation Report (OIR-B1-1802)

Raintree Village Condominium, Inc.

2101 Sunset Pointe Rd, Building 200, Units 201-206

As of 5/8/2023 | FPAT File# MUD2318333

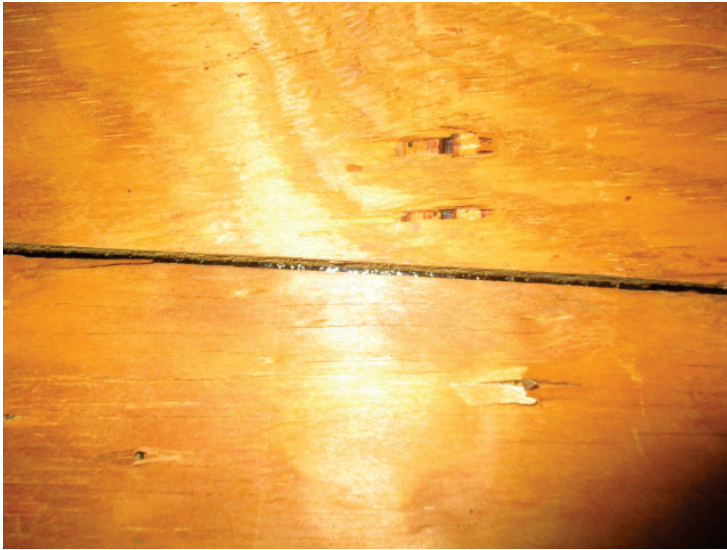
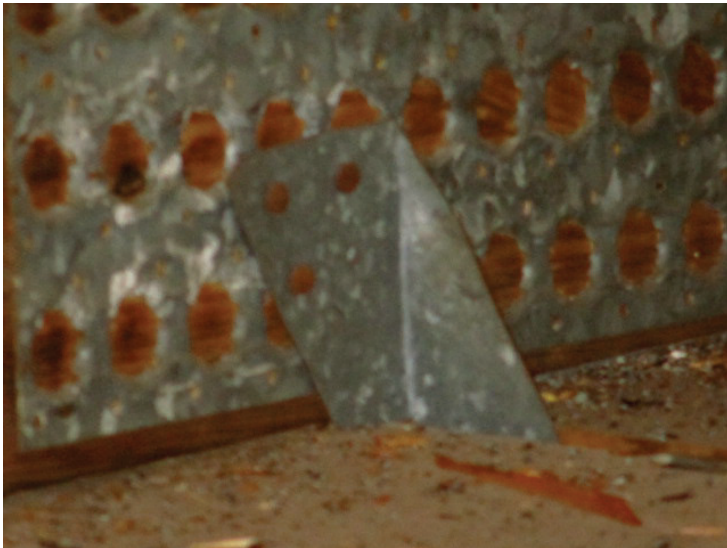
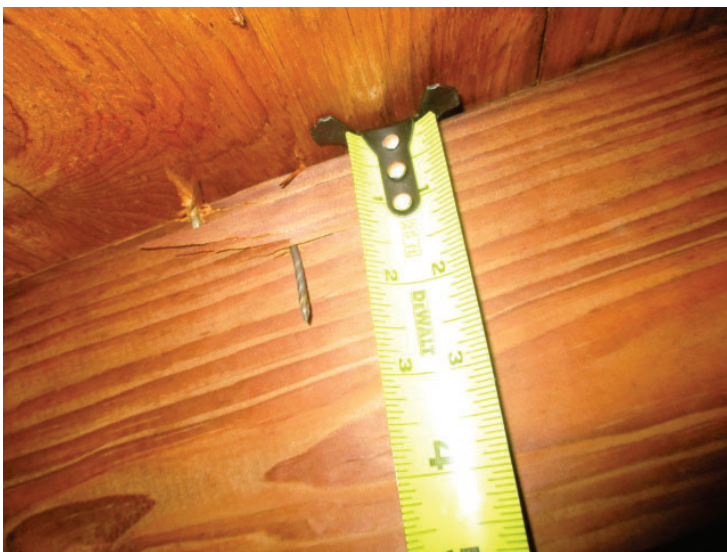
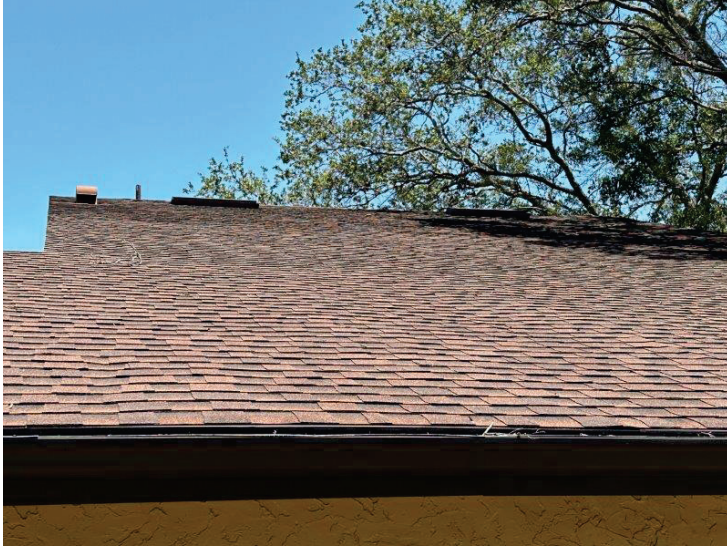
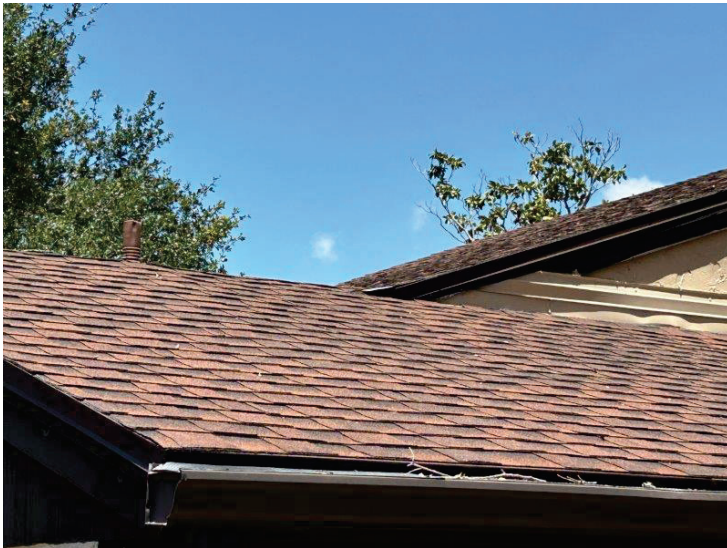
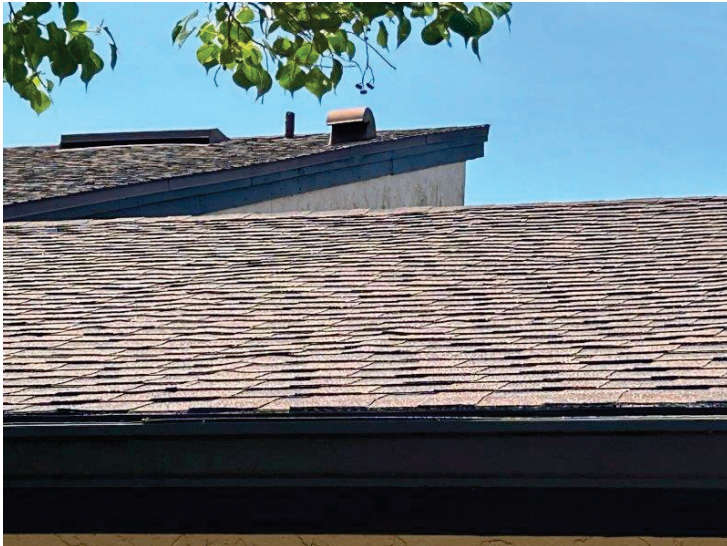
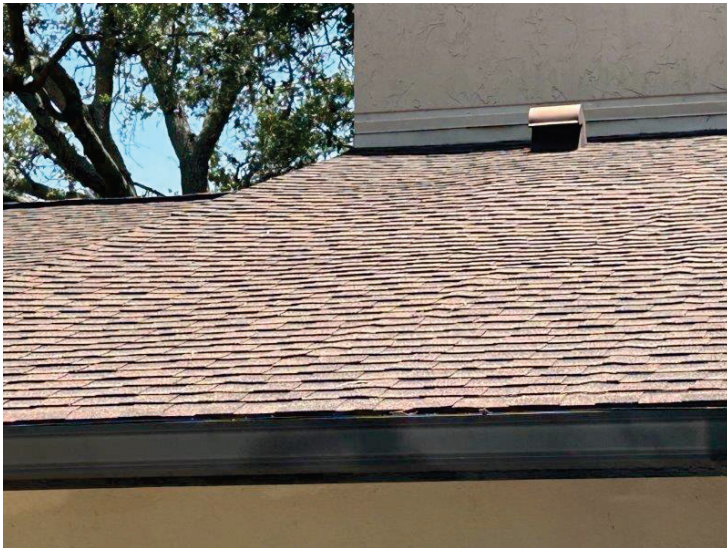
Roof Construction

Comments: | Level B
Inspection verified 1/2" plywood roof deck attached with 8d nails at a minimum of 6" on the edge & 12" in the field. |

Comments: | Clips
Inspection verified hurricane clips fastened with a minimum of three nails. |

Comments: | Other Roof
Inspection verified a gable roof shape. |

Comments: | Yes
SWR was verified at time of inspection. The Secondary Water Resistance verified is a self-adhering peel and stick. |
