Windstorm Mitigation Report (OIR-B1-1802)

Raintree Village Condominium, Inc.

2101 Sunset Point Rd, Clubhouse

As of 7/1/2020 | FPAT File# MUD2014600

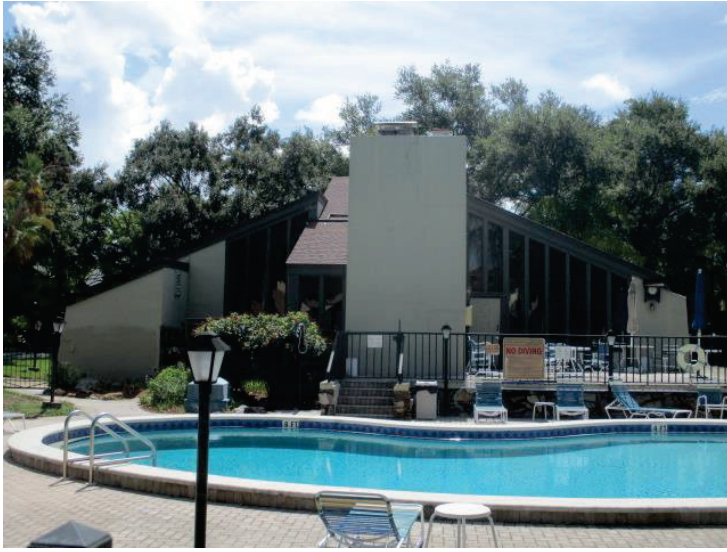
Exterior Elevation

- 5. Roof Geometry:** **Other Roof**
Comments: Inspection verified a gable roof shape.
- 6. SWR:** **No**
Comments: No SWR verified.
- 7. Opening Protection:** **None or Some Glazed Openings**
Comments: No opening protection verified at the time of inspection.

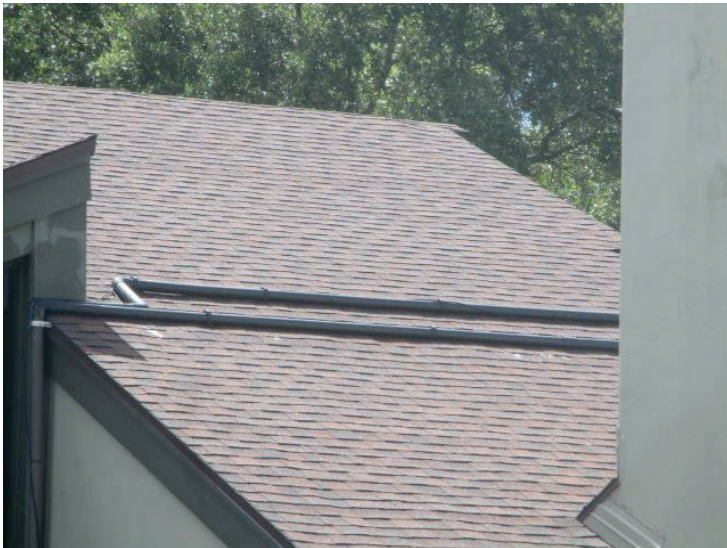
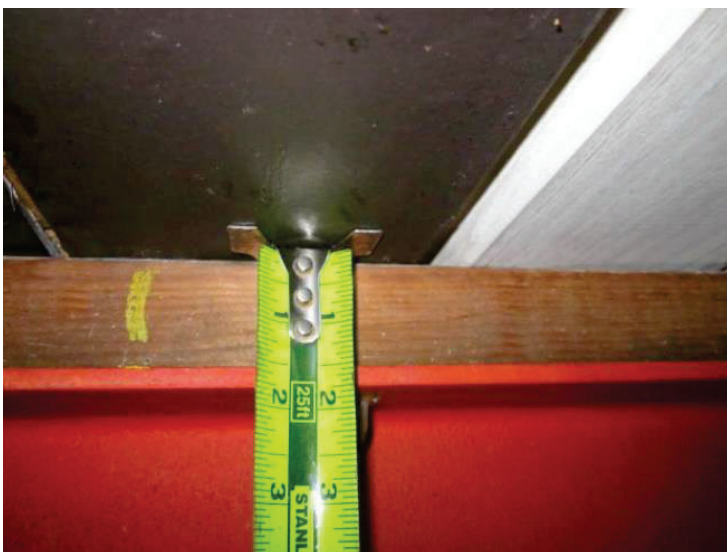
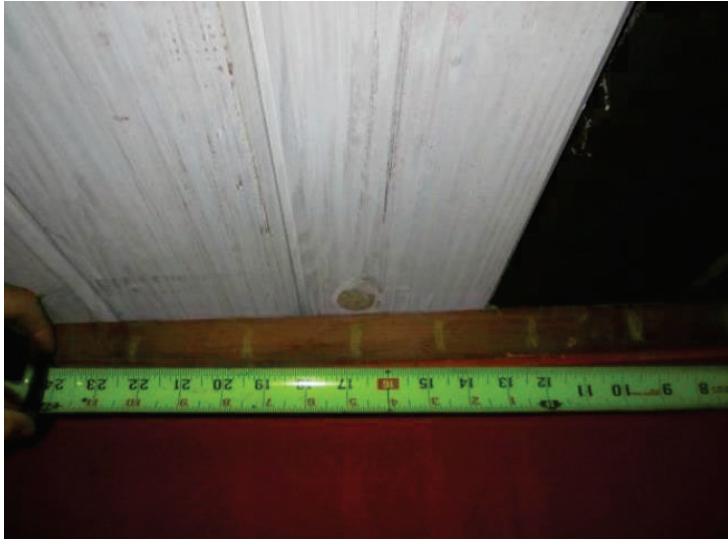
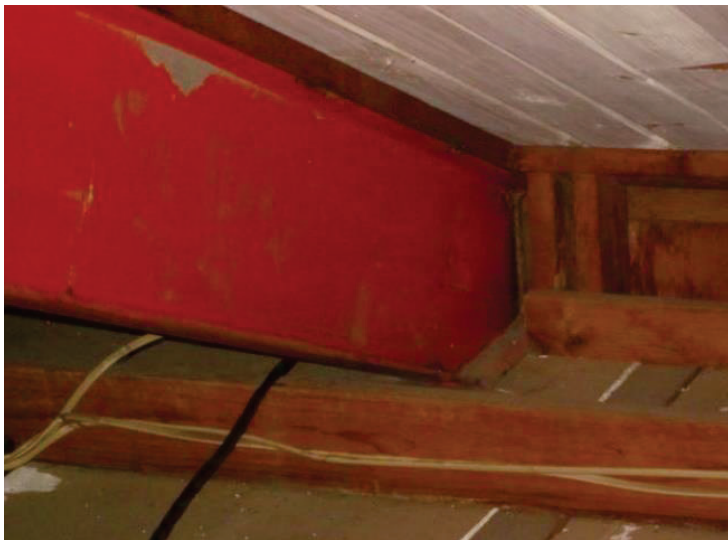
Roof Construction

- 3. Roof Deck Attachment:** **Level C**
Comments: Inspection verified tongue & groove decking with a minimum of 2 nails per board
- 4. Roof to Wall Attachment:** **Structural**
Comments: Inspection verified metal I-Beam roof support system welded to metal I-Beam wall support system. See attached photos
