COMMERCIAL WINDSTORM MITIGATION REPORT (OIR-B1-1802)

Raintree Village Condominium
2101 Sunset Point Rd, Units 501-502
Clearwater, FL 33765

As of 7/1/2020
FPAT File# MUD2014600

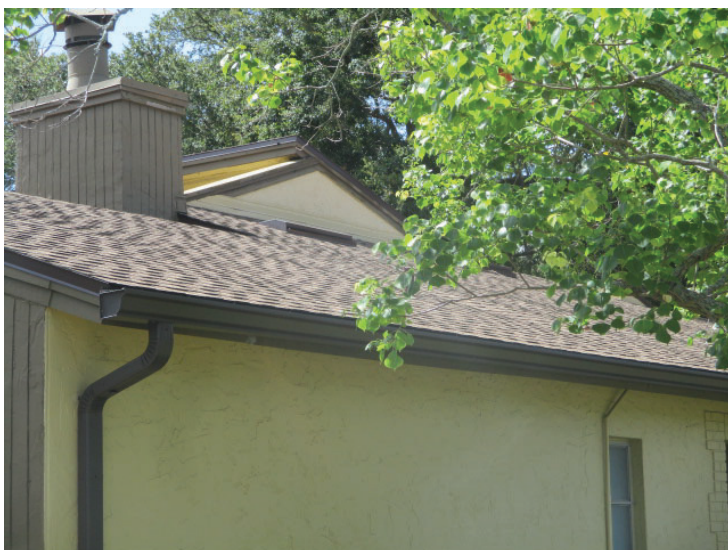
Roof Construction

- 3. Roof Deck Attachment:** **Level C**
Comments: Inspection verified 1/2" plywood roof deck attached with 8d nails at a minimum 6" on the edge & 6" in the field.

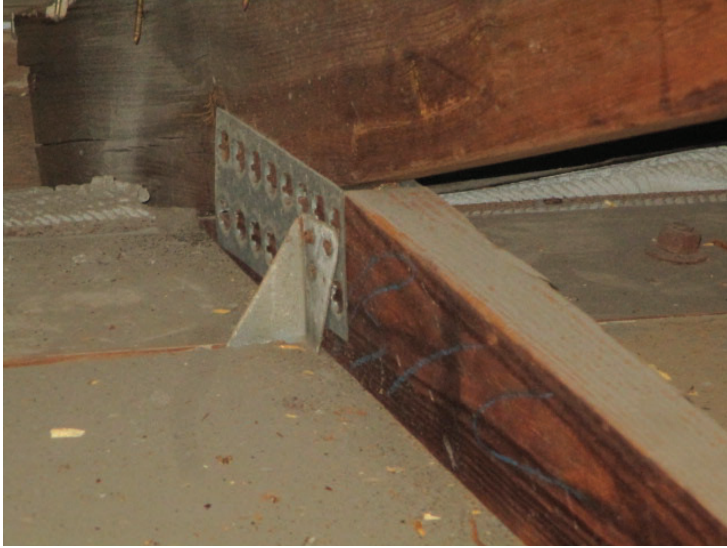
Roof Construction

- 4. Roof to Wall Attachment:** **Clips**
Comments: Inspection verified hurricane clips fastened with a minimum of three nails.
- 5. Roof Geometry:** **Other Roof**
Comments: Inspection verified a gable roof shape.
