Windstorm Mitigation Report (OIR-B1-1802)

Raintree Village Condominium, Inc.

2101 Sunset Pointe Rd, Building 300, Units 301-306

As of 5/8/2023 | FPAT File# MUD2318333

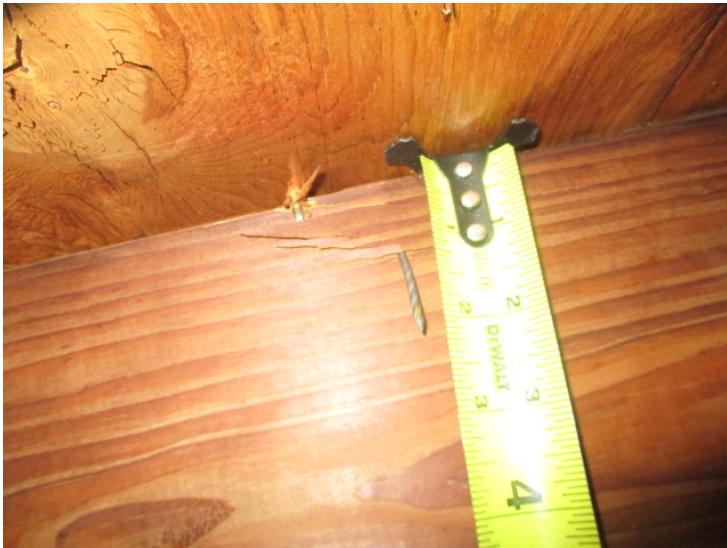
Roof Construction

Comments: | Level B
Inspection verified 1/2" plywood roof deck attached with 8d nails at a minimum of 6" on the edge & 12" in the field. |
