Windstorm Mitigation Report (OIR-B1-1802)

Raintree Village Condominium, Inc.
2101 Sunset Point Rd, Units 701-706
Clearwater, FL 33765

As of 07-01-2020 | FPAT File# MUD2014600

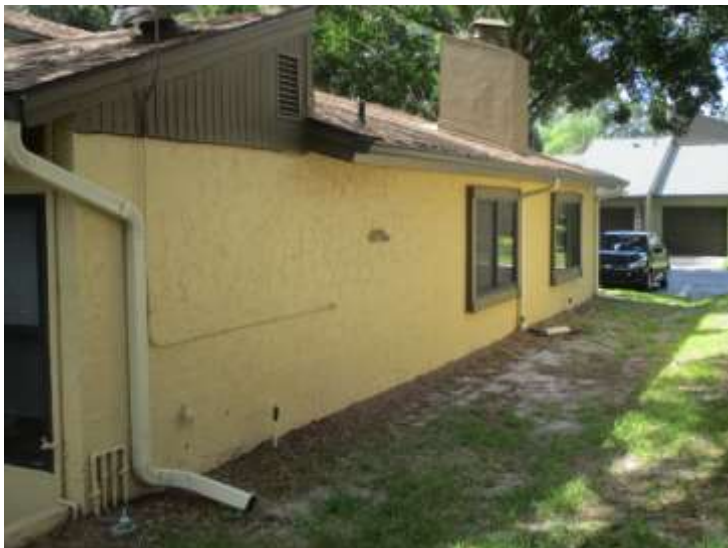
Exterior Elevation

- 4. Roof to Wall Attachment:** **Clips**
Comments: Inspection verified hurricane clips fastened with a minimum of three nails.
- 5. Roof Geometry:** **Other Roof**
Comments: Inspection verified a gable roof shape.

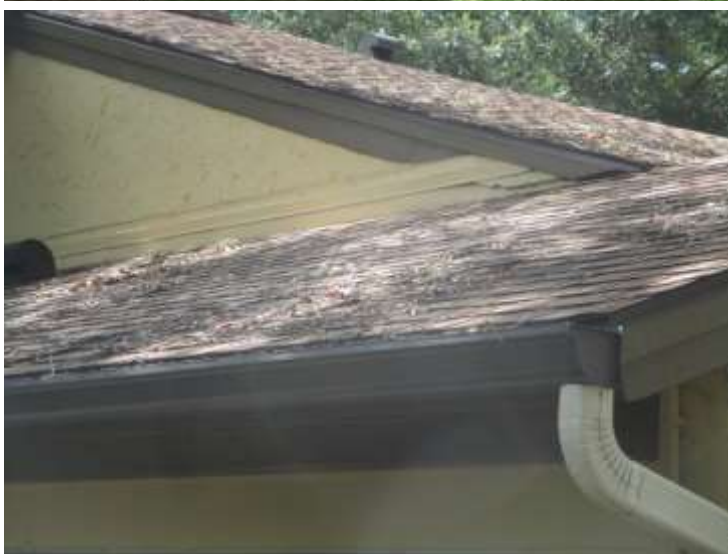
Roof Construction

- 3. Roof Deck Attachment:** **Level C**
Comments: Inspection verified 1/2" plywood roof deck attached with 8d nails at a minimum 6" on the edge & 6" in the field.
