COMMERCIAL WINDSTORM MITIGATION REPORT (OIR-B1-1802)

Raintree Village Condominium
2101 Sunset Point Rd, Units 801-806
Clearwater, FL 33765

As of 7/1/2020
FPAT File# MUD2014600

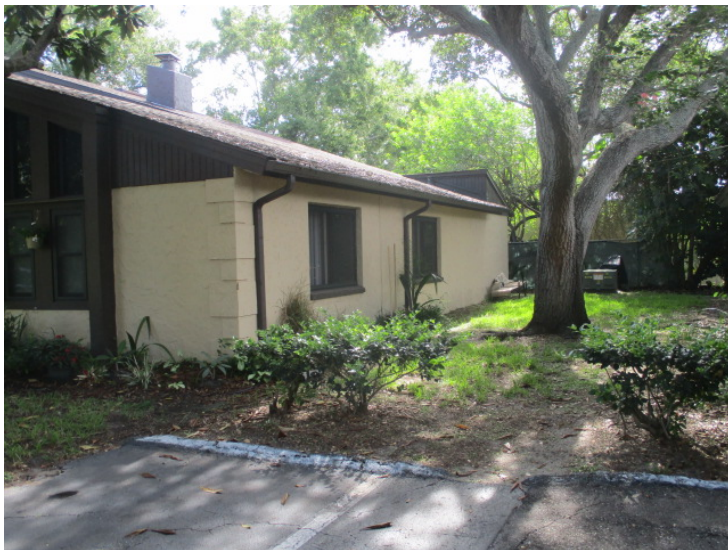
Exterior Elevation

- 4. Roof to Wall Attachment:** **Clips**
Comments: Inspection verified hurricane clips fastened with a minimum of three nails.
- 5. Roof Geometry:** **Other Roof**
Comments: Inspection verified a gable roof shape.

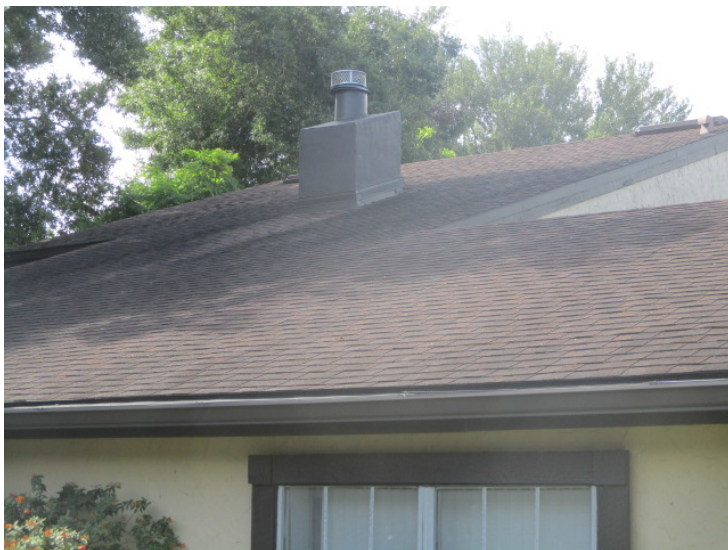
Roof Construction

- 3. Roof Deck Attachment:** **Level C**
Comments: Inspection verified 1/2" plywood roof deck attached with 8d nails at a minimum 6" on the edge & 6" in the field.
