Windstorm Mitigation Report (OIR-B1-1802)

Raintree Village Condominium, Inc.

2101 Sunset Pointe Rd, Building 600, Units 601-606

As of 5/8/2023 | FPAT File# MUD2318333

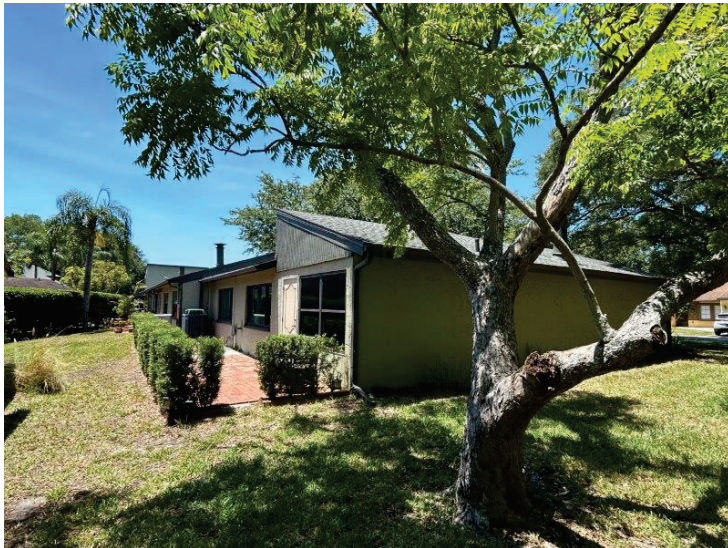
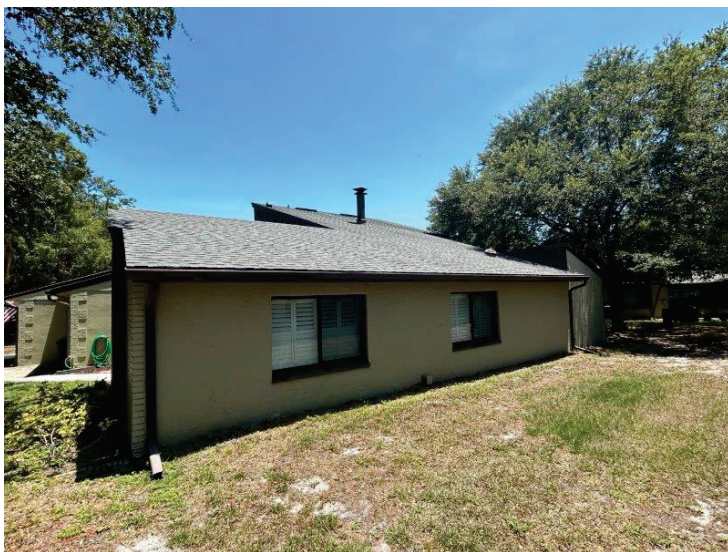
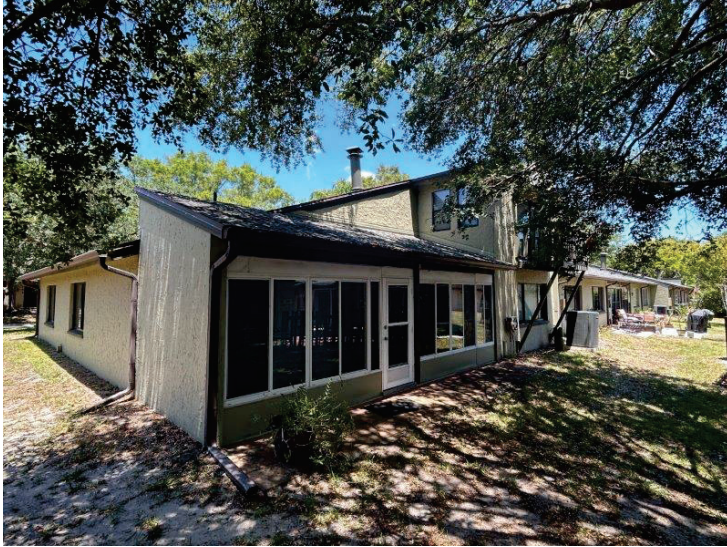
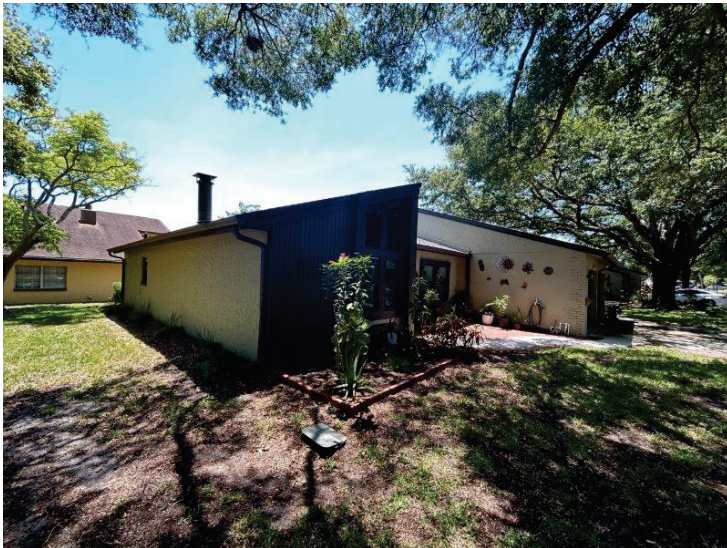
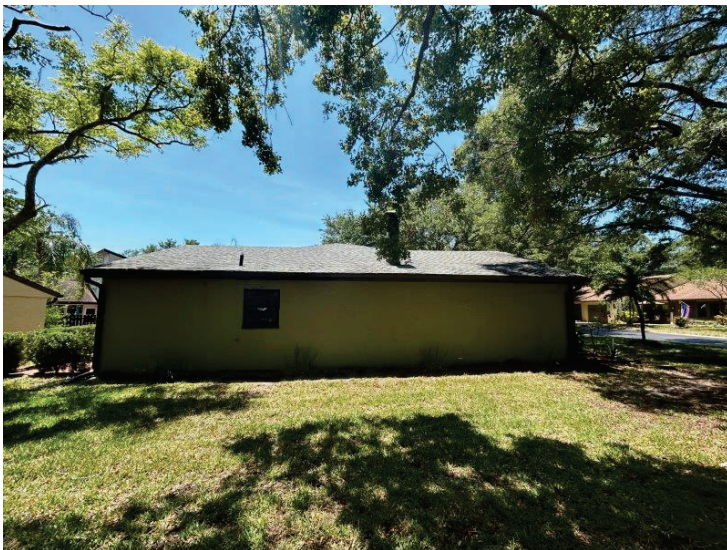
Exterior Elevation

Comments: | Other Roof
Inspection verified a gable roof shape. |

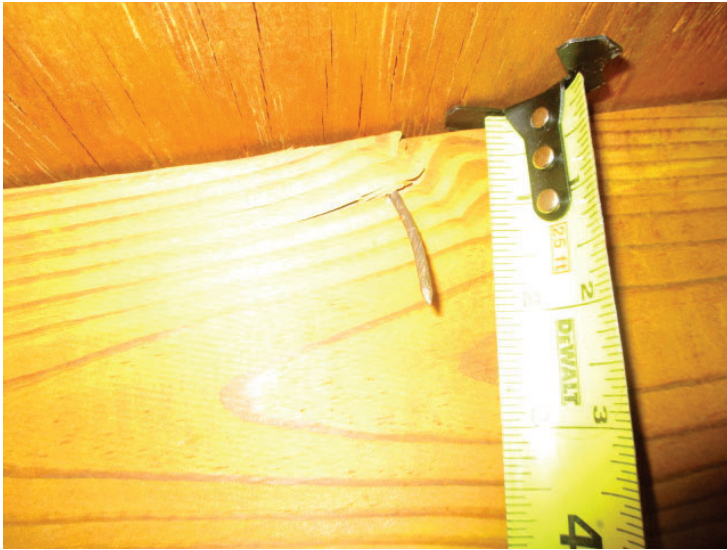
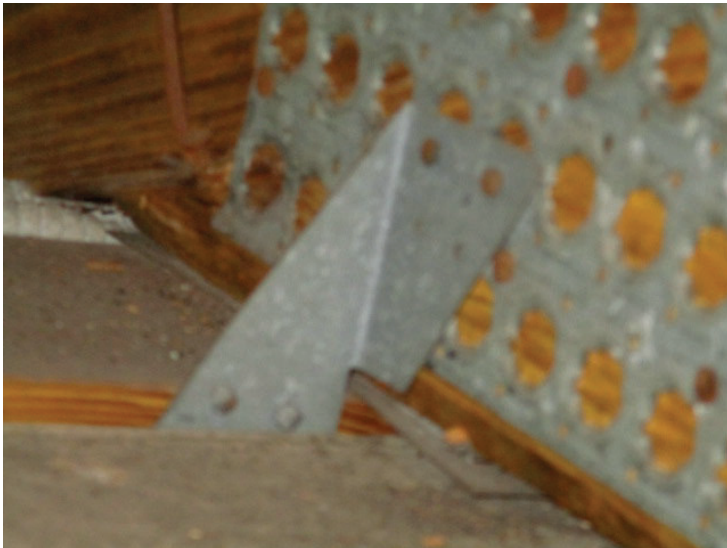
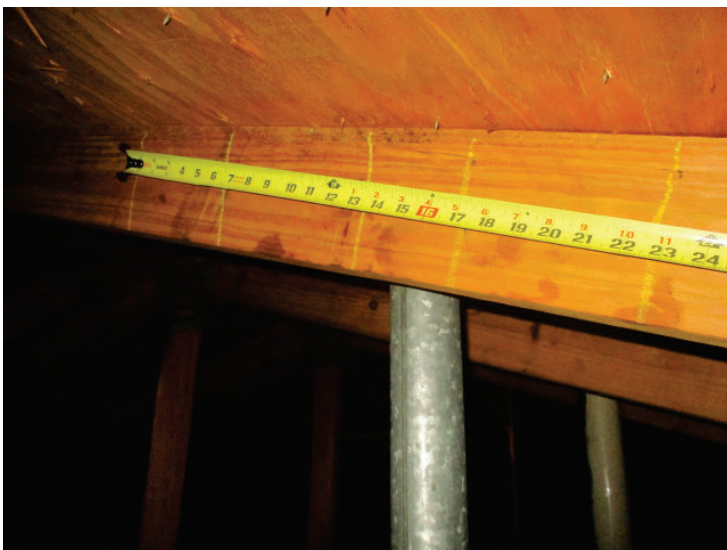
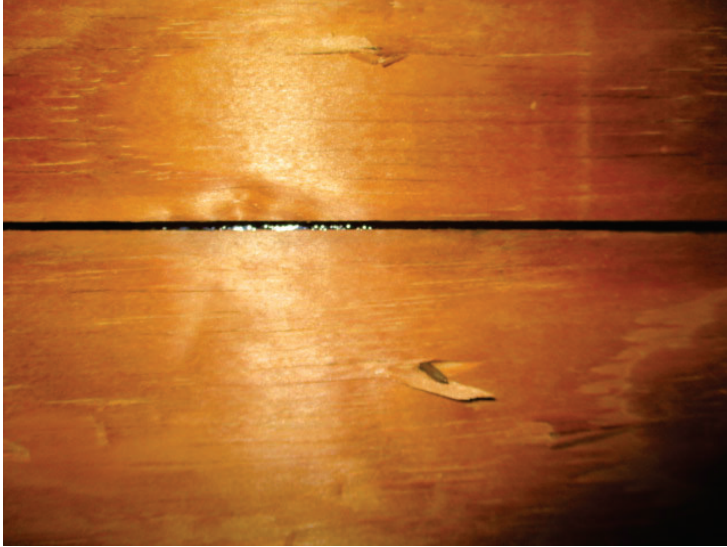
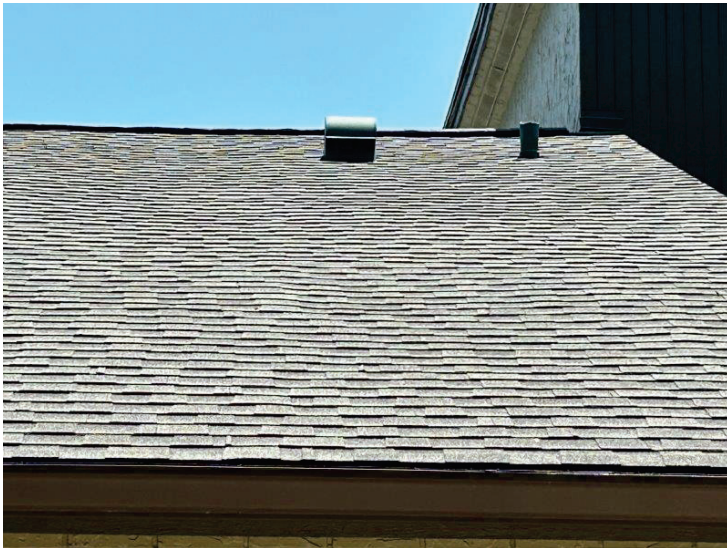
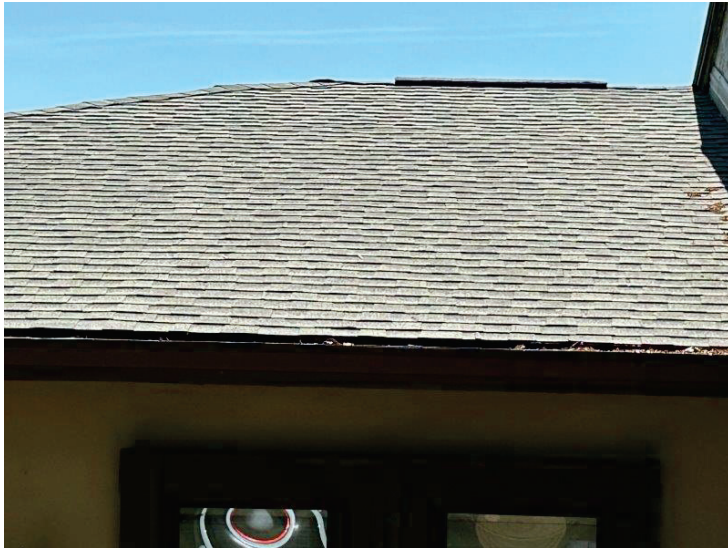
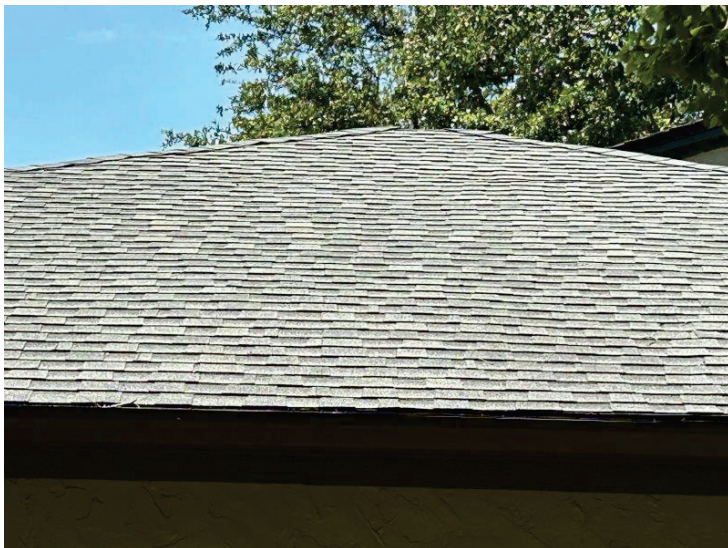
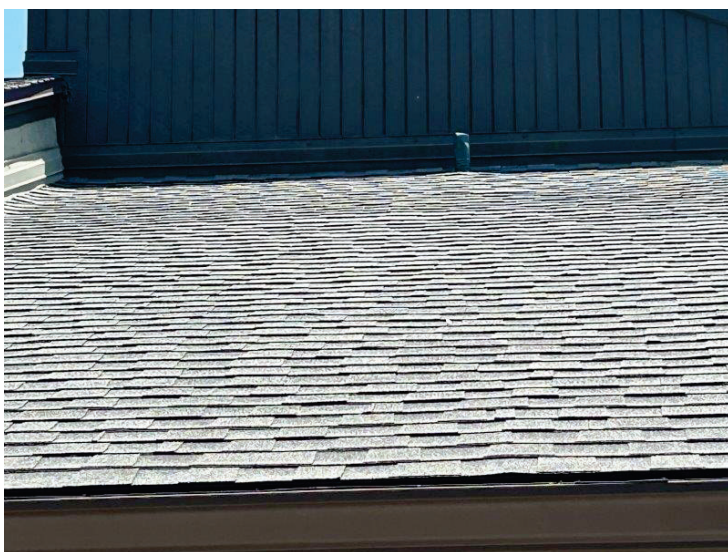
Roof Construction

Comments: | Level B
Inspection verified 1/2" plywood roof deck attached with 8d nails at a minimum of 6" on the edge & 12" in the field. |

Comments: | Toe Nails
Inspection verified hurricane clips fastened with less than three nails. |

Comments: | Yes
SWR was verified at time of inspection. The Secondary Water Resistance verified is a self-adhering peel and stick. |
