Windstorm Mitigation Report (OIR-B1-1802)

Raintree Village Condominium, Inc.

2101 Sunset Pointe Rd, Building 900, Units 901-902

As of 5/8/2023 | FPAT File# MUD2318333

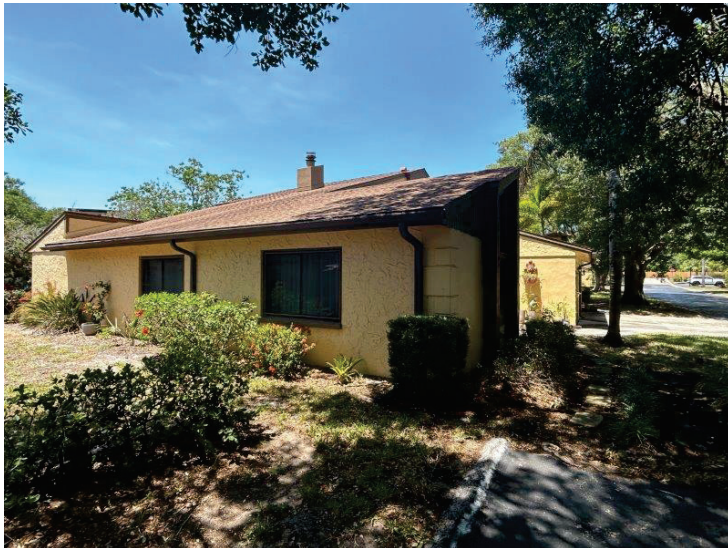
Exterior Elevation

Comments: | Other Roof
Inspection verified a gable roof shape. |

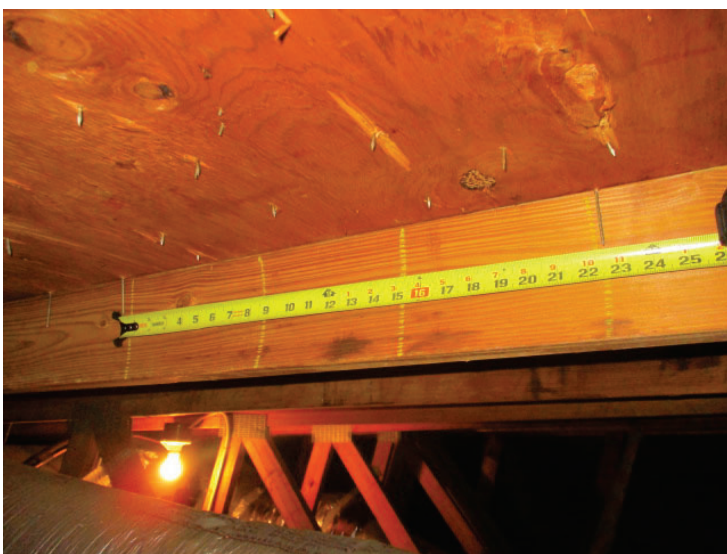
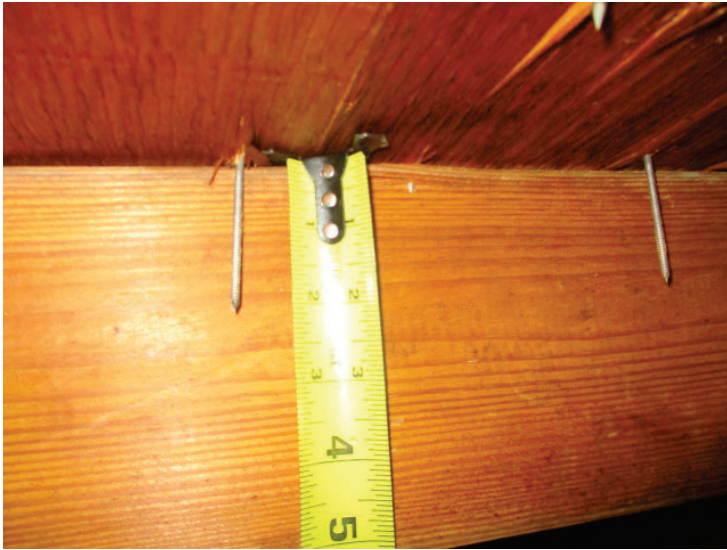
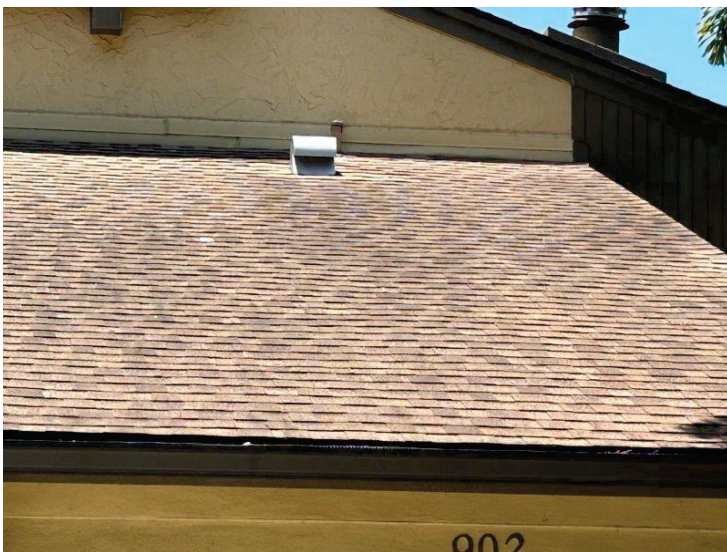
Roof Construction

Comments: | Level B
Inspection verified 1/2" plywood roof deck attached with 8d nails at a minimum of 6" on the edge & 12" in the field. |

Comments: | Clips
Inspection verified hurricane clips fastened with a minimum of three nails. |

Comments: | Yes
SWR was verified at time of inspection. The Secondary Water Resistance verified is a self-adhering peel and stick. |
