Windstorm Mitigation Report (OIR-B1-1802)

Raintree Village Condominium, Inc.
2101 Sunset Point Rd, Units 1001-1004
Clearwater, FL 33765

As of 07-01-2020 | FPAT File# MUD2014600

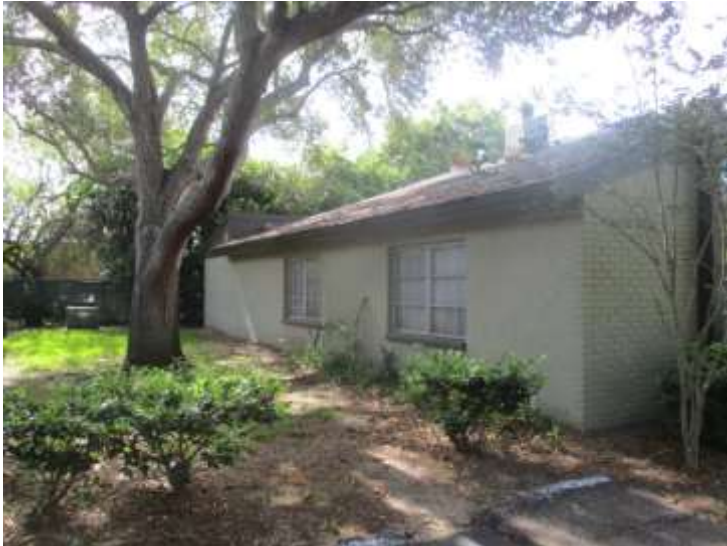
Exterior Elevation

- 4. Roof to Wall Attachment:** **Clips**
Comments: Inspection verified hurricane clips fastened with a minimum of three nails.
- 5. Roof Geometry:** **Other Roof**
Comments: Inspection verified a gable roof shape.

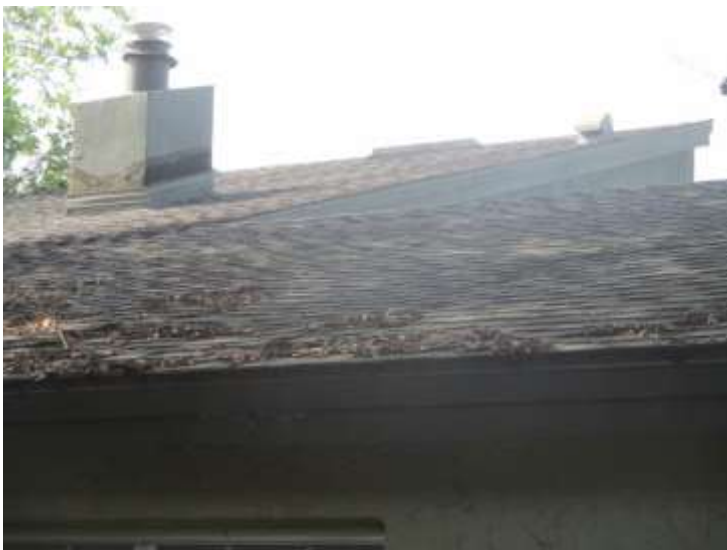
Roof Construction

- 3. Roof Deck Attachment:** **Level C**
Comments: Inspection verified 1/2" plywood roof deck attached with 8d nails at a minimum 6" on the edge & 6" in the field.
