COMMERCIAL WINDSTORM MITIGATION REPORT (OIR-B1-1802)

Raintree Village Condominium
2101 Sunset Point Rd, Units 1201-1202
Clearwater, FL 33765

As of 7/1/2020
FPAT File# MUD2014600

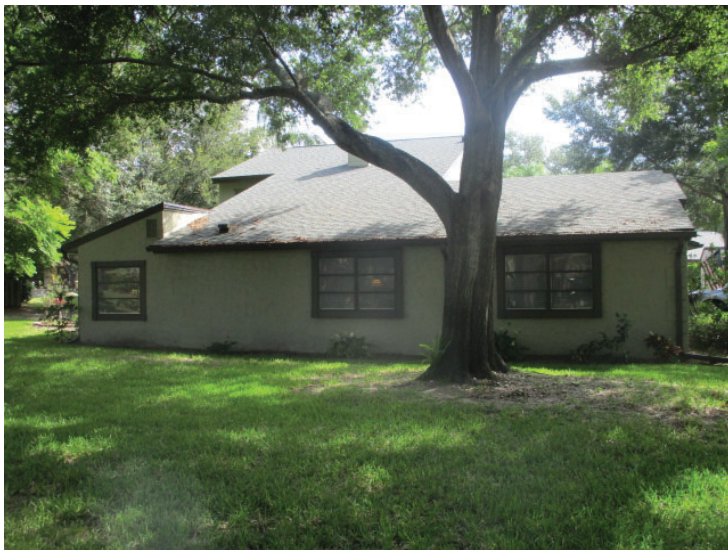
Exterior Elevation

- 4. Roof to Wall Attachment:** **Clips**
Comments: Inspection verified hurricane clips fastened with a minimum of three nails.
- 5. Roof Geometry:** **Other Roof**
Comments: Inspection verified a gable roof shape.

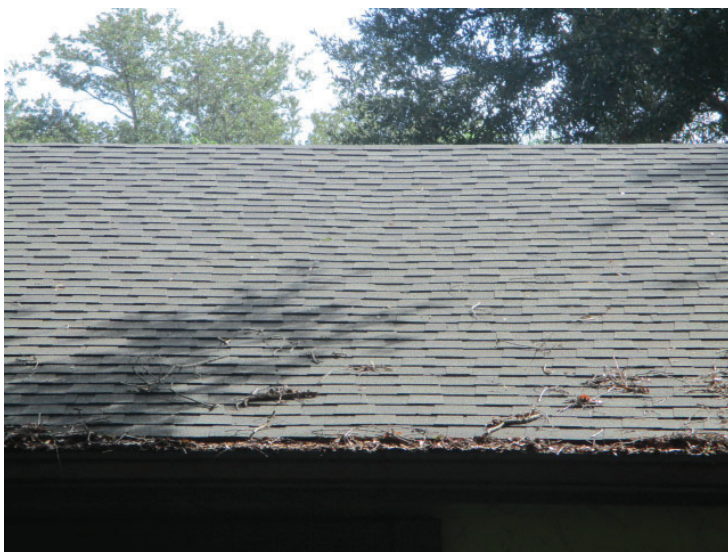
Roof Construction

- 3. Roof Deck Attachment:** **Level C**
Comments: Inspection verified 1/2" plywood roof deck attached with 8d nails at a minimum 6" on the edge & 6" in the field.
