COMMERCIAL WINDSTORM MITIGATION REPORT (OIR-B1-1802)

Raintree Village Condominium
2101 Sunset Point Rd, Units 1401-1406
Clearwater, FL 33765

As of 7/1/2020
FPAT File# MUD2014600

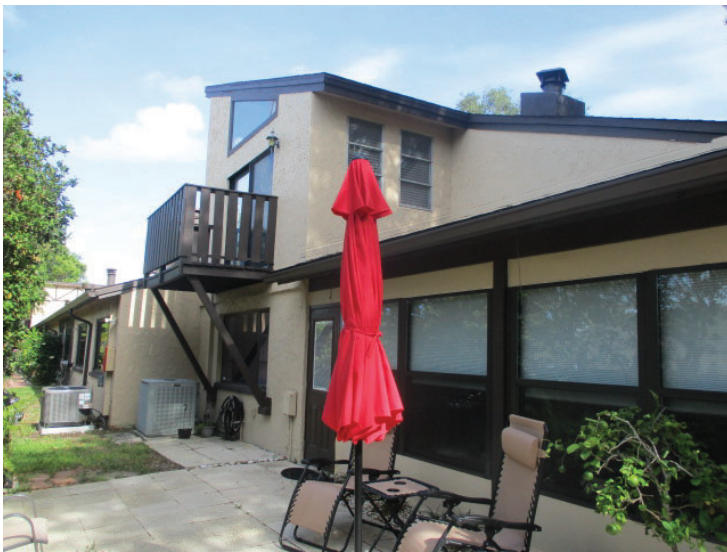
Exterior Elevation

- 4. Roof to Wall Attachment:** **Clips**
Comments: Inspection verified hurricane clips fastened with a minimum of three nails.
- 5. Roof Geometry:** **Other Roof**
Comments: Inspection verified a gable roof shape.

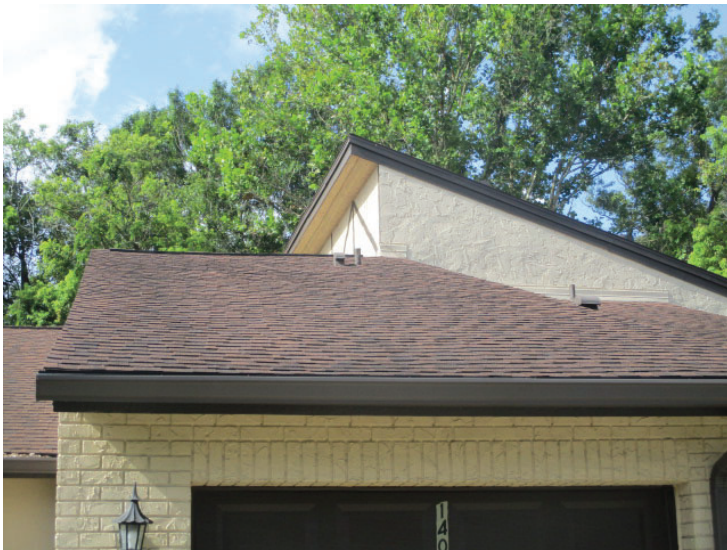
Roof Construction

- 3. Roof Deck Attachment:** **Level C**
Comments: Inspection verified 1/2" plywood roof deck attached with 8d nails at a minimum 6" on the edge & 6" in the field.
