Windstorm Mitigation Report (OIR-B1-1802)

Raintree Village Condominium, Inc.
2101 Sunset Point Rd, Units 1601-1602
Clearwater, FL 33765

As of 07-01-2020 | FPAT File# MUD2014600

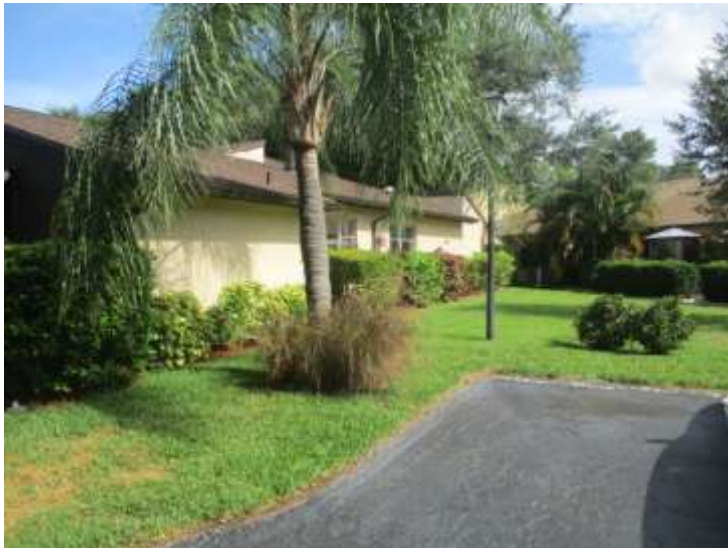
Exterior Elevation

- 4. Roof to Wall Attachment:** **Clips**
Comments: Inspection verified hurricane clips fastened with a minimum of three nails.
- 5. Roof Geometry:** **Other Roof**
Comments: Inspection verified a gable roof shape.

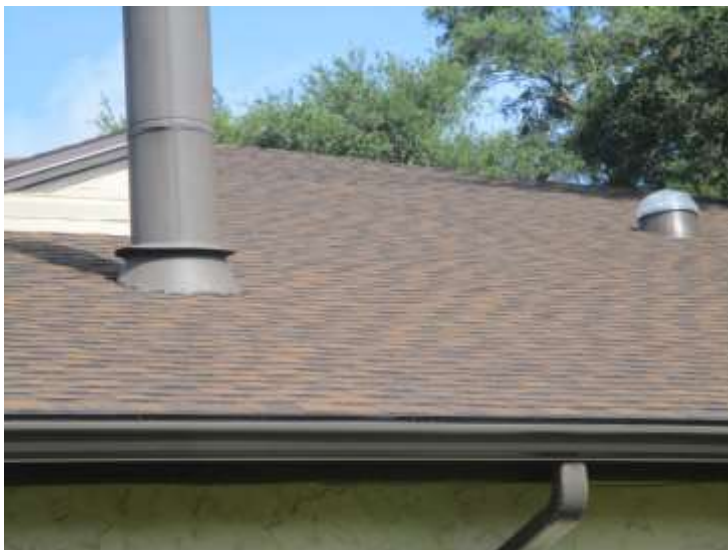
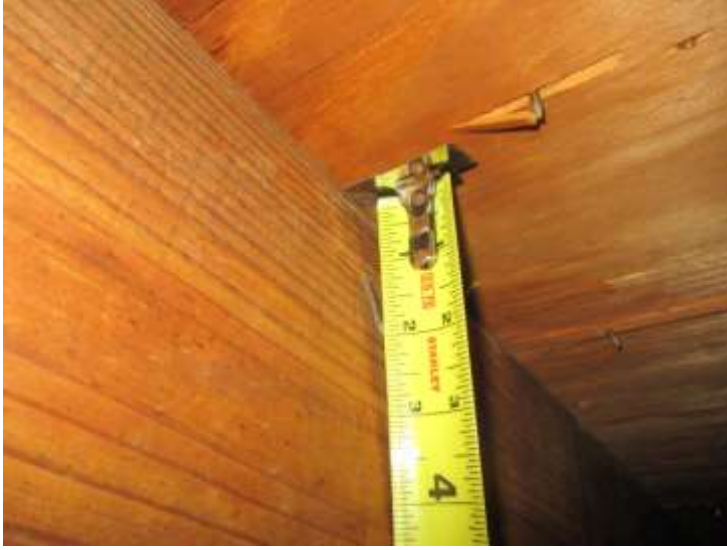
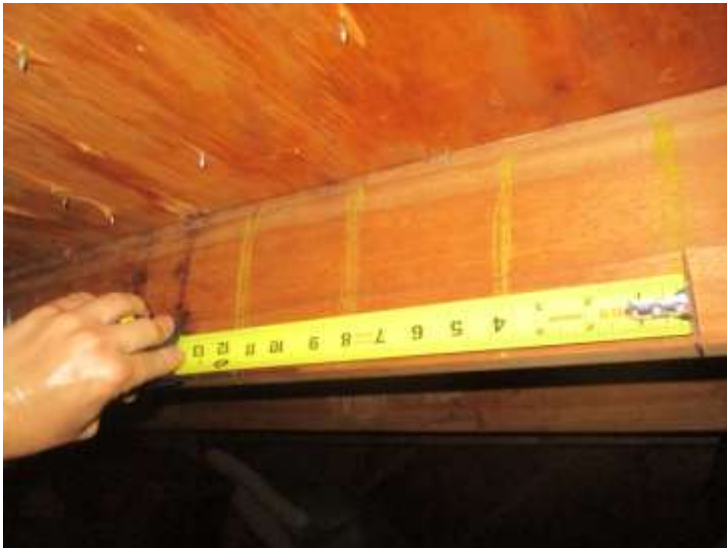
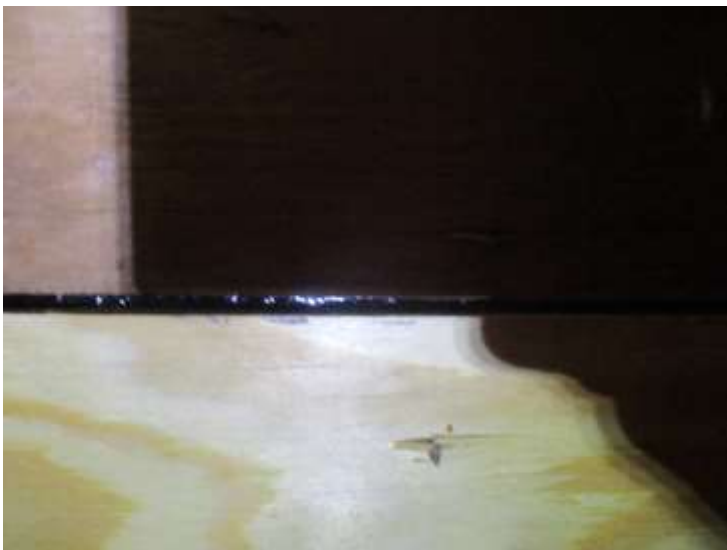
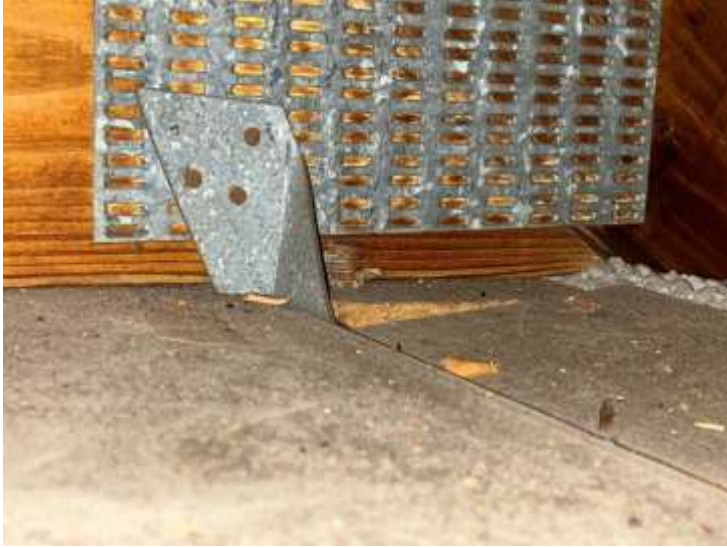
Roof Construction

- 3. Roof Deck Attachment:** **Level C**
Comments: Inspection verified 1/2" plywood roof deck attached with 8d nails at a minimum 6" on the edge & 6" in the field.

- 6. SWR:** **Yes**
Comments: SWR was verified at time of inspection. The Secondary Water Resistance verified is a self-adhering peel and stick.
- 7. Opening Protection:** **None or Some Glazed Openings**
Comments: No opening protection verified at the time of inspection.
