Windstorm Mitigation Report (OIR-B1-1802)

Raintree Village Condominium, Inc.

2101 Sunset Pointe Rd, Building 1500, Units 1501-1502

As of 5/8/2023 | FPAT File# MUD2318333

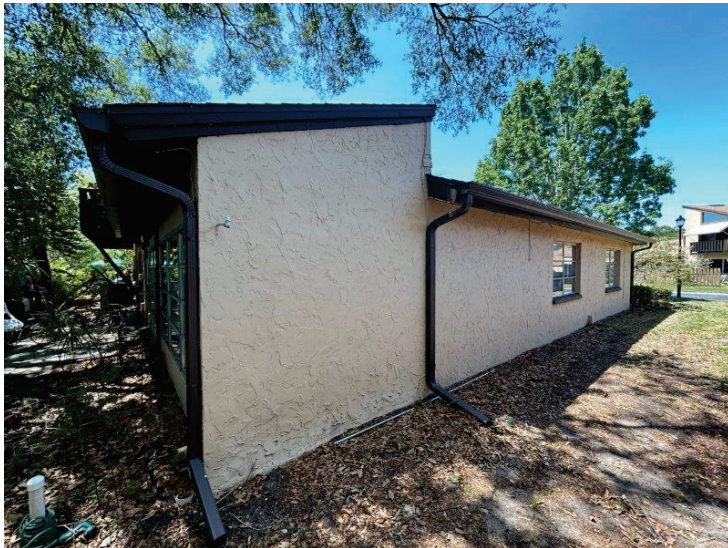
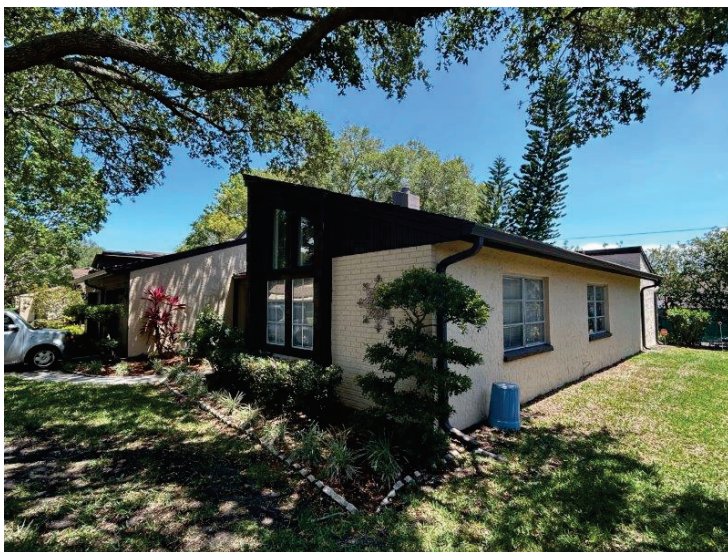
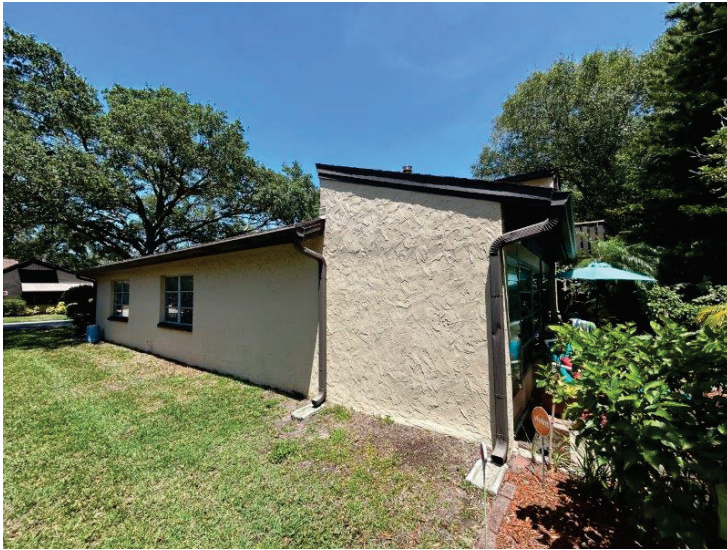
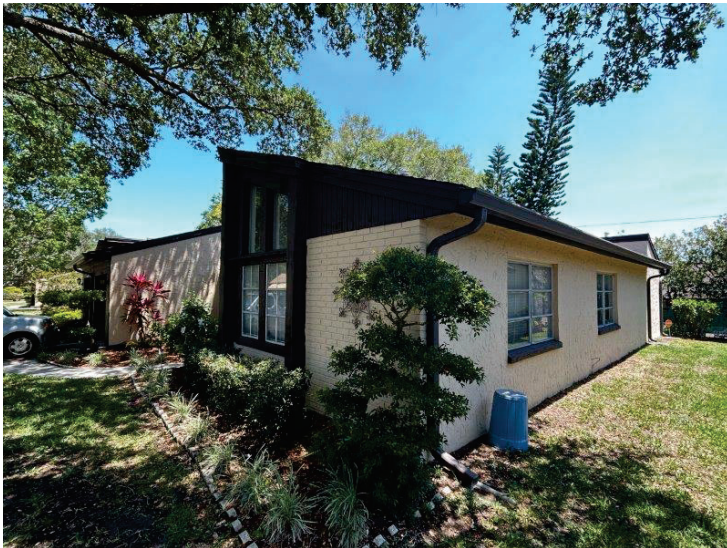
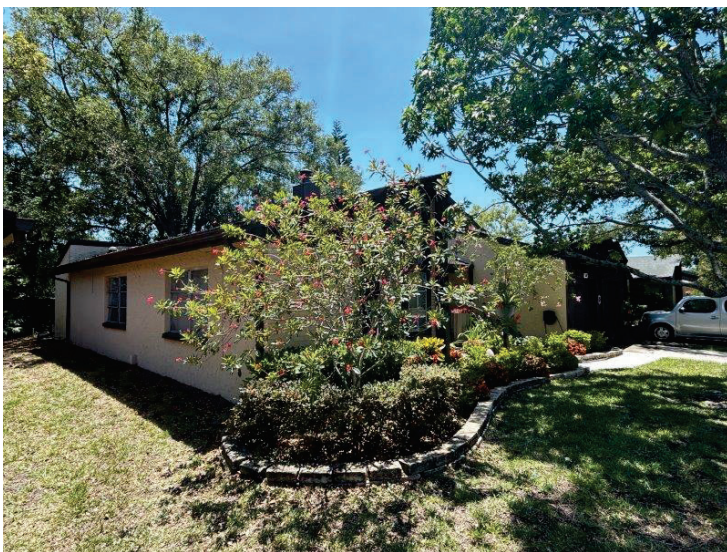
Comments: | None or Some Glazed Openings
Inspection verified no opening protection. |

Exterior Elevation

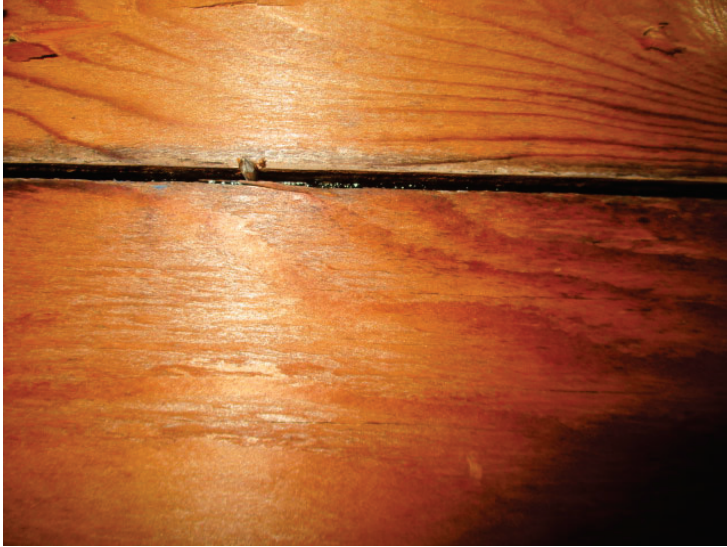
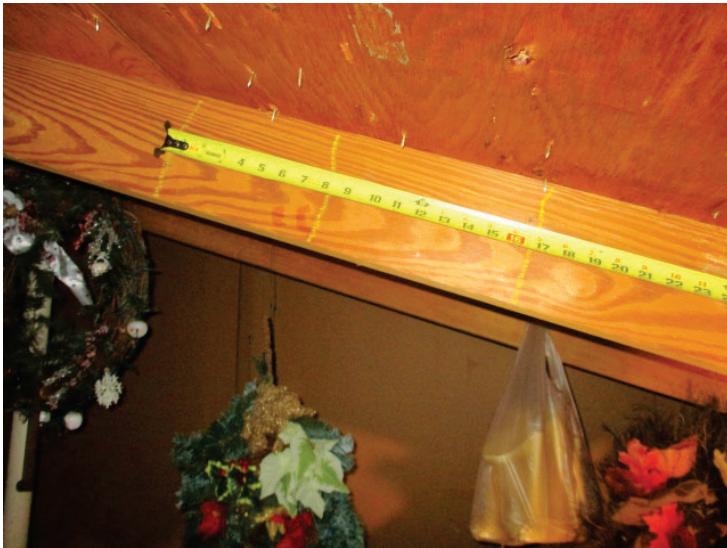
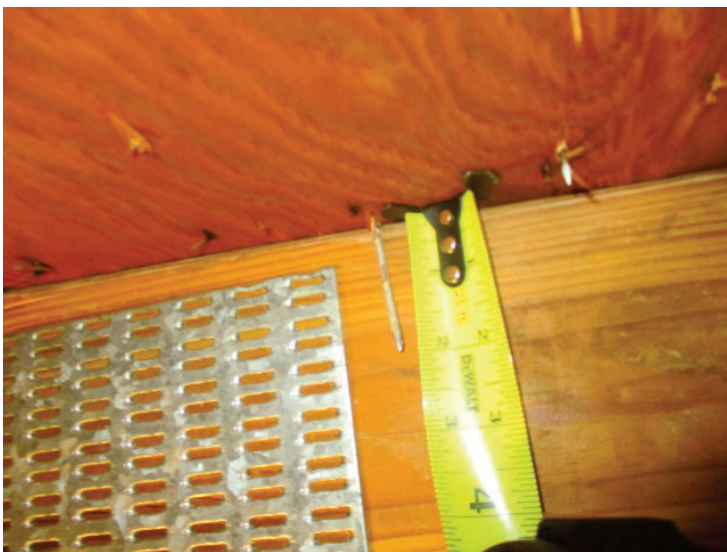
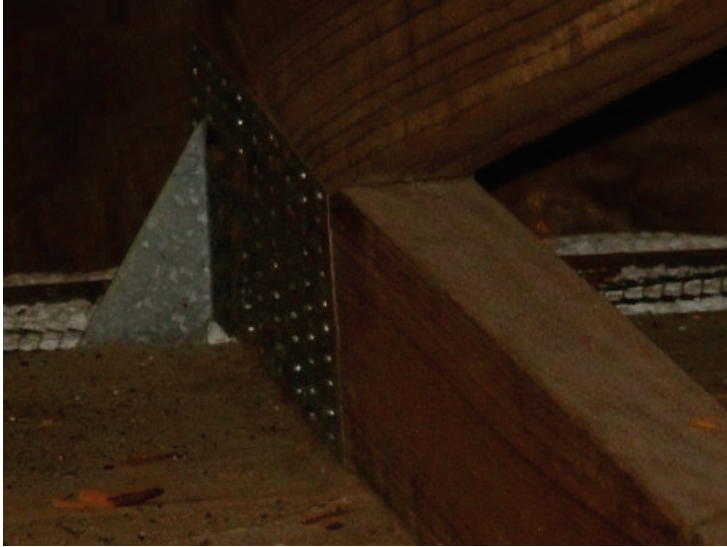
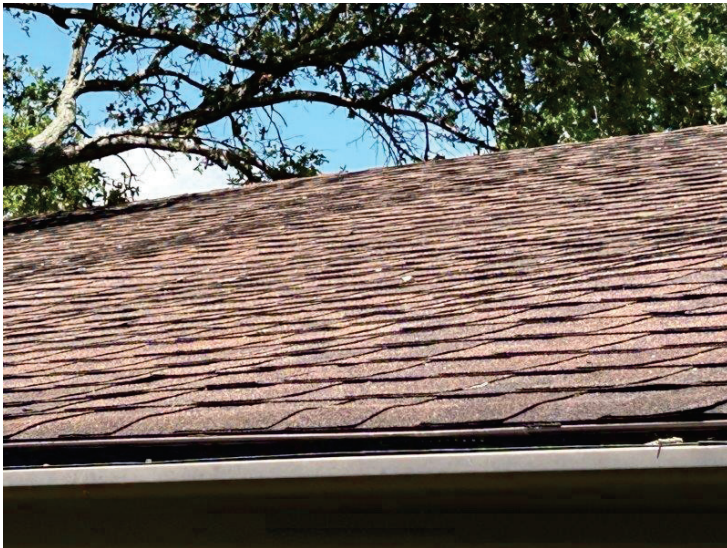
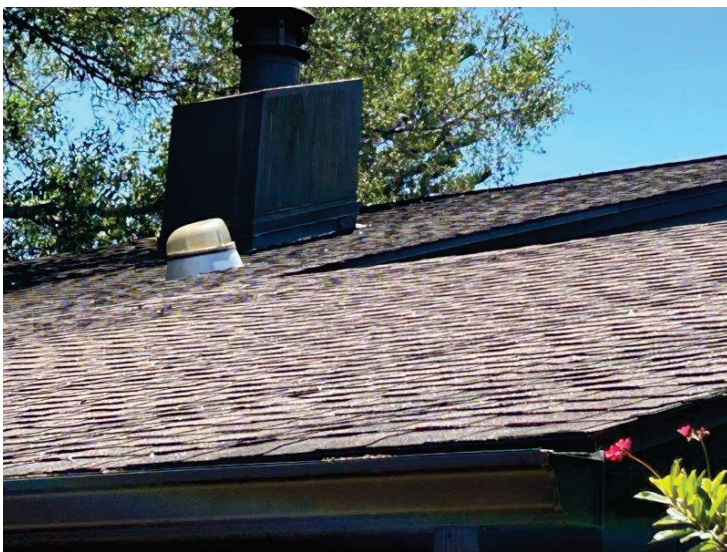
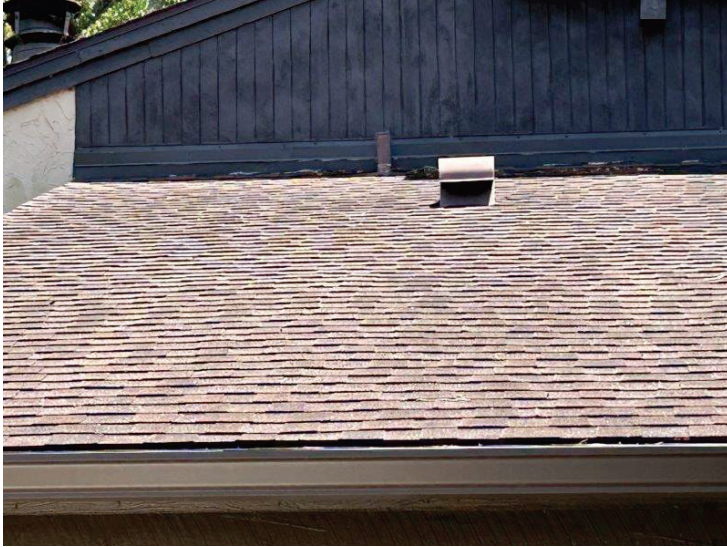
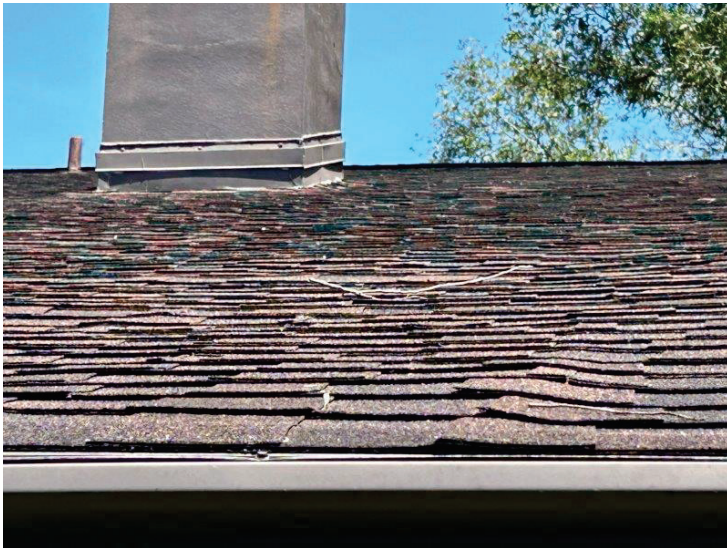
Comments: | Level B
Inspection verified 1/2" plywood roof deck attached with 8d nails at a minimum of 6" on the edge & 12" in the field. |

Comments: | Clips
Inspection verified hurricane clips fastened with a minimum of three nails. |

Comments: | Other Roof
Inspection verified a gable roof shape. |

Comments: | Yes
SWR was verified at time of inspection. The Secondary Water Resistance verified is a self-adhering peel and stick. |

Roof Construction
