## **Windstorm Mitigation Report (OIR-B1-1802)**

Raintree Village Condominium, Inc.  
2101 Sunset Point Rd, Units 1701-1702  
Clearwater, FL 33765

As of 9/9/2021 | FPAT File# MUD2014600

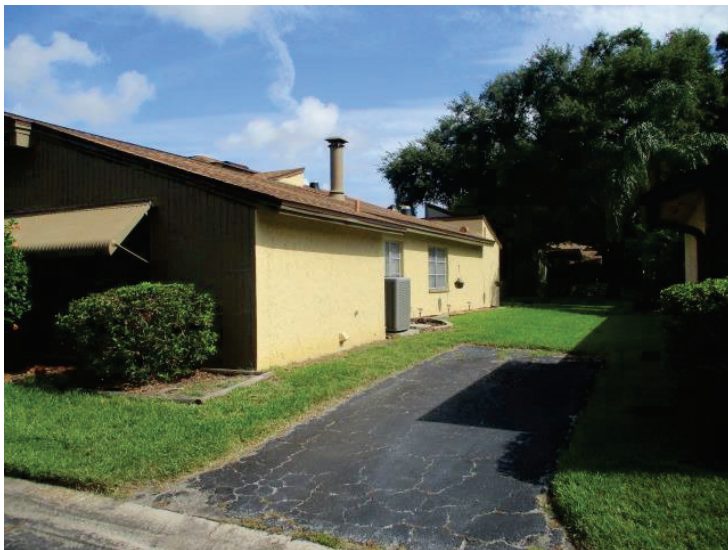
Exterior Elevation

- 4. Roof to Wall Attachment:** **Clips**  
Comments: Inspection verified hurricane clips fastened with a minimum of three nails.
- 5. Roof Geometry:** **Other Roof**  
Comments: Inspection verified a gable roof shape.

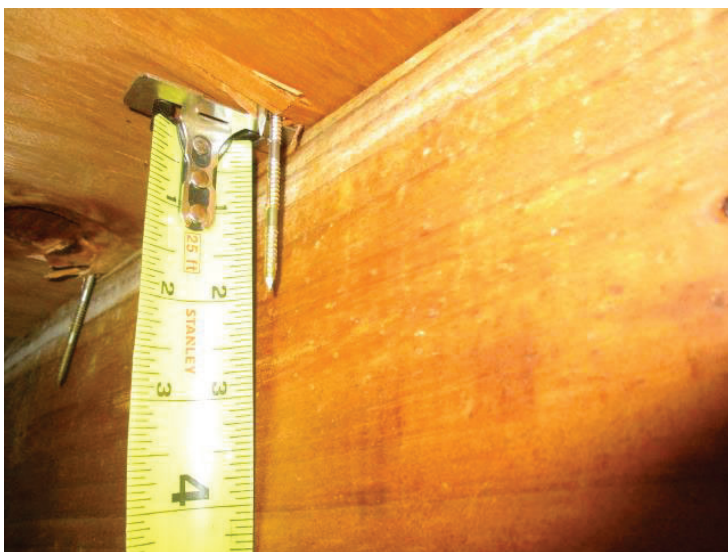
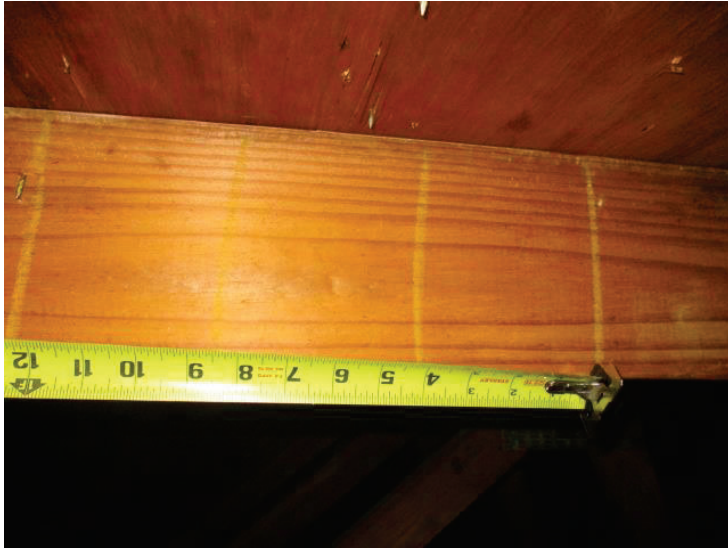
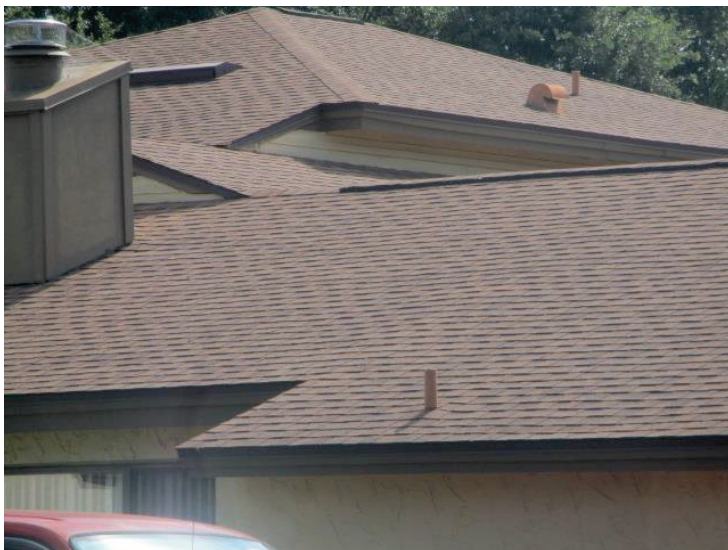
Roof Construction

- 3. Roof Deck Attachment:** **Level C**  
Comments: Inspection verified 1/2" plywood roof deck attached with 8d nails at a minimum 6" on the edge & 6" in the field.

- 6. SWR:** **Yes**  
Comments: SWR was verified at time of inspection. The Secondary Water Resistance verified is a self-adhering peel and stick.
- 7. Opening Protection:** **None or Some Glazed Openings**  
Comments: No opening protection verified at the time of inspection.
