Windstorm Mitigation Report (OIR-B1-1802)

Raintree Village Condominium, Inc.
2101 Sunset Point Rd, Units 2201-2202
Clearwater, FL 33765

As of 11-25-2020 | FPAT File# MUD2015282

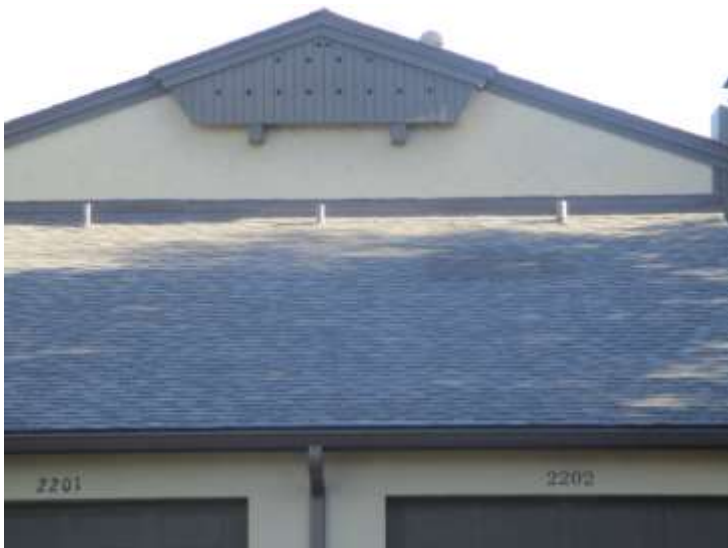
Roof Construction

- 3. Roof Deck Attachment:** **Level C**
Comments: Inspection verified 1/2" plywood roof deck attached with 8d nails at a minimum 6" on the edge & 6" in the field.

- 4. Roof to Wall Attachment:** **Clips**
Comments: Inspection verified hurricane clips fastened with a minimum of three nails.
- 5. Roof Geometry:** **Other Roof**
Comments: Inspection verified a gable roof shape.
