Windstorm Mitigation Report (OIR-B1-1802)

Raintree Village Condominium, Inc.
2101 Sunset Point Rd, Units 2401-2402
Clearwater, FL 33765

As of 11-25-2020 | FPAT File# MUD2015282

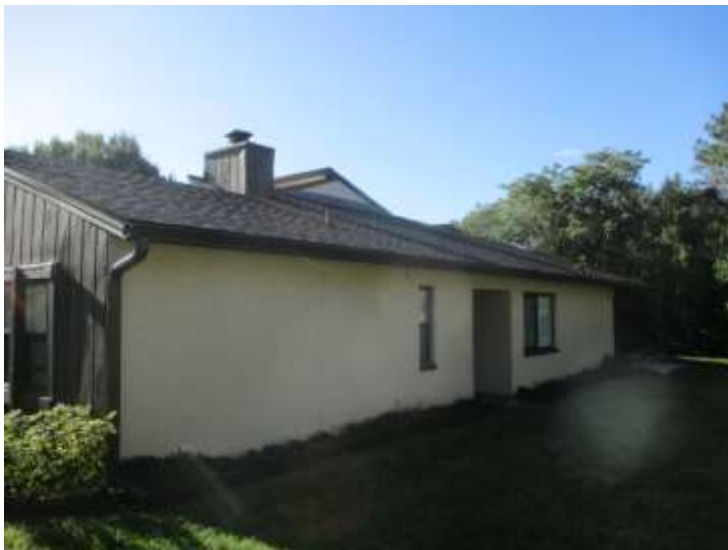
Exterior Elevation

- 4. Roof to Wall Attachment:** **Clips**
Comments: Inspection verified hurricane clips fastened with a minimum of three nails.
- 5. Roof Geometry:** **Other Roof**
Comments: Inspection verified a gable roof shape.

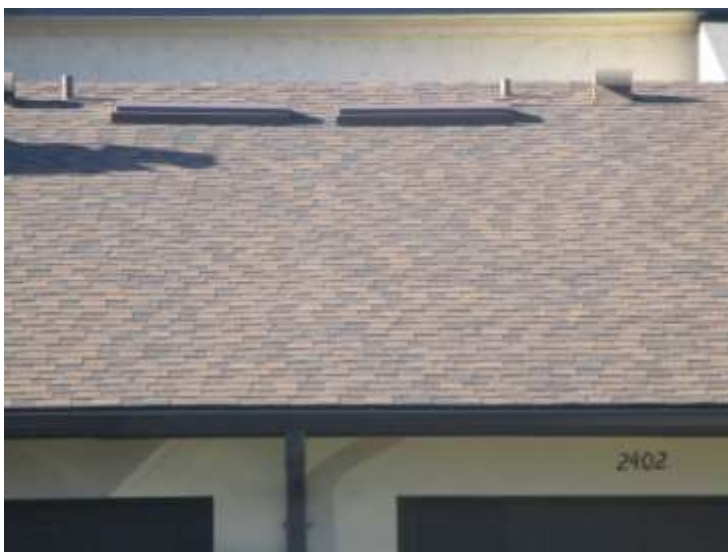
Roof Construction

- 3. Roof Deck Attachment:** **Level C**
Comments: Inspection verified 1/2" plywood roof deck attached with 8d nails at a minimum 6" on the edge & 6" in the field.

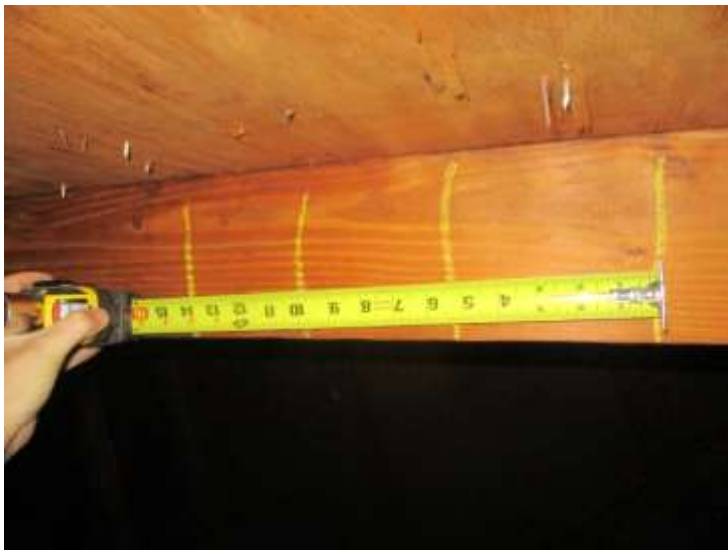
Roof Construction

- 6. SWR:** **Yes**
Comments: SWR was verified at time of inspection. The Secondary Water Resistance verified is a self-adhering peel and stick.
- 7. Opening Protection:** **None or Some Glazed Openings**
Comments: Inspection verified some impact rated opening protection. Not all glazed openings were protected with impact resistant coverings.

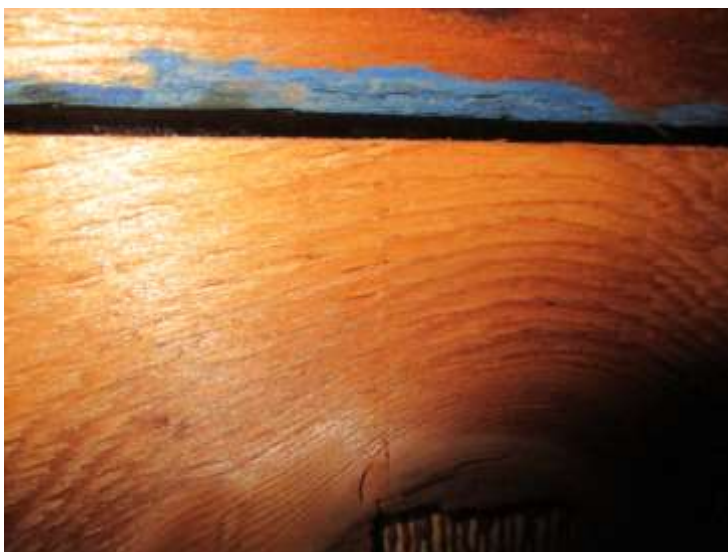
Roof Construction

- 2. Roof Covering:** **FBC Equivalent**
Comments: The roof covering was replaced in 2020. The roof permit was confirmed and the permit number is BCP2020-070709. This roof was verified as meeting the building code requirements outlined on the mitigation affidavit.
