## **Windstorm Mitigation Report (OIR-B1-1802)**

Raintree Village Condominium, Inc.  
2101 Sunset Point Rd, Units 1901-1902  
Clearwater, FL 33765

As of 9/9/2021 | FPAT File# MUD2014600

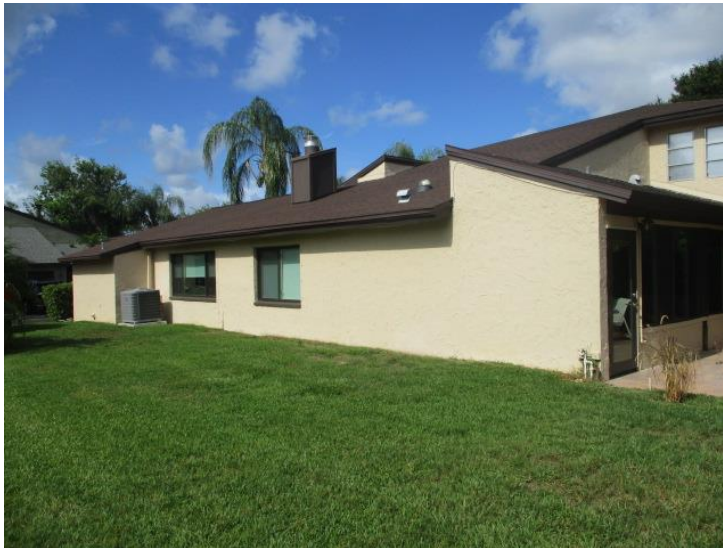
Exterior Elevation

- 4. Roof to Wall Attachment:** **Clips**  
Comments: Inspection verified hurricane clips fastened with a minimum of three nails.
- 5. Roof Geometry:** **Other Roof**  
Comments: Inspection verified a gable roof shape.

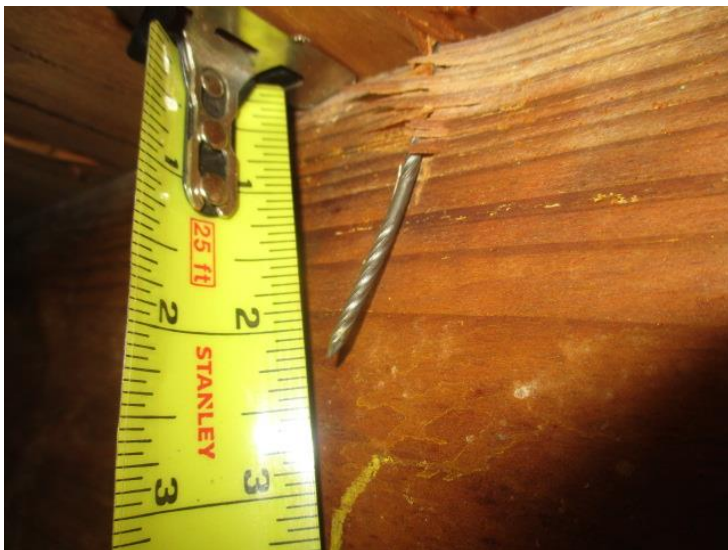
Roof Permit  
Information

- 2. Roof Covering:** **FBC Equivalent**  
Comments: The roof covering was replaced in 2013. The roof permit was confirmed and the permit number is BCP2013-05193. This roof was verified as meeting the building code requirements outlined on the mitigation affidavit.

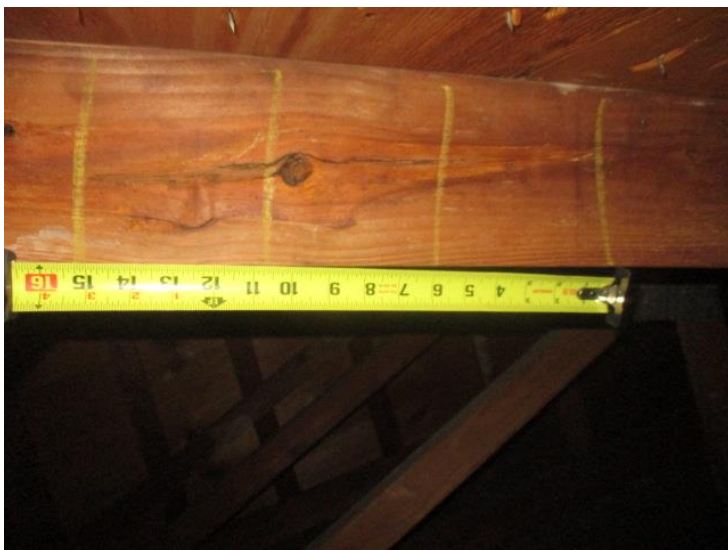
Roof Construction

- 3. Roof Deck Attachment:** **Level C**  
Comments: Inspection verified 1/2" plywood roof deck attached with 8d nails at a minimum 6" on the edge & 6" in the field.

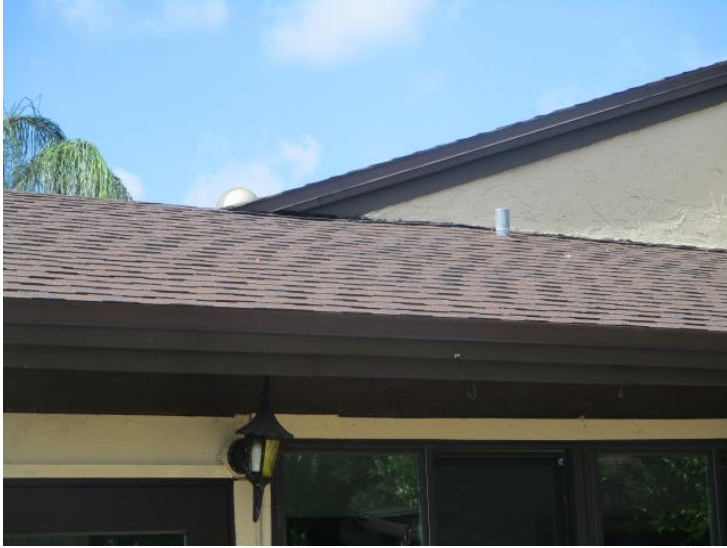
Roof Construction

- 6. SWR:** **Yes**  
Comments: SWR was verified at time of inspection. The Secondary Water Resistance verified is a self-adhering peel and stick.
- 7. Opening Protection:** **None or Some Glazed Openings**  
Comments: No opening protection verified at the time of inspection.
