## **RECAPITULATION OF MITIGATION FEATURES** **For 2101 Sunset Point Rd, Units 2101-2105**

## Uniform Mitigation Verification Inspection Form

Inspection Date: 7/1/2020		
<b>Owner Information</b>		
Owner Name: Raintree Village Condominium		Contact Person: Robert Kelly
Address: 2101 Sunset Point Rd, Units 2101-2105		Home Phone:
City: Clearwater	Zip: 33765	Work Phone: (727) 726-8000
County: Pinellas		Cell Phone:
Insurance Company:		Policy #:
Year of Home: 1973	# of Stories: 2	Email:

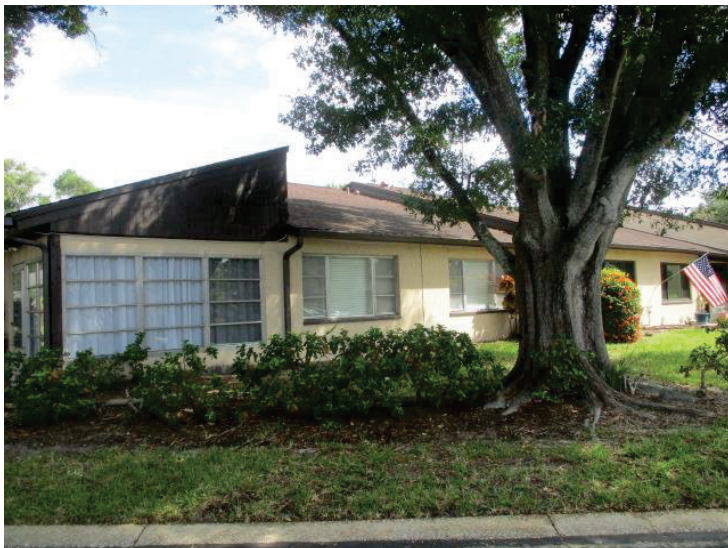
Exterior Elevation

5. **Roof Geometry:**                      **Other Roof**  
Comments:                                      Inspection verified a gable roof shape.
6. **SWR:**                                      **Yes**  
Comments:                                      SWR was verified at time of inspection. The Secondary Water Resistance verified is a self-adhering peel and stick.

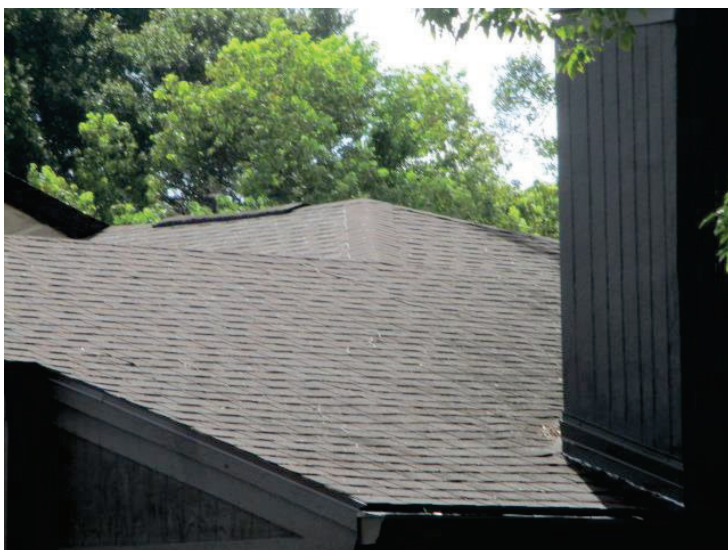
Roof Construction

3. **Roof Deck Attachment:**        **Level C**  
Comments:                                      Inspection verified 1/2" plywood roof deck attached with 8d nails at a minimum 6" on the edge & 6" in the field.

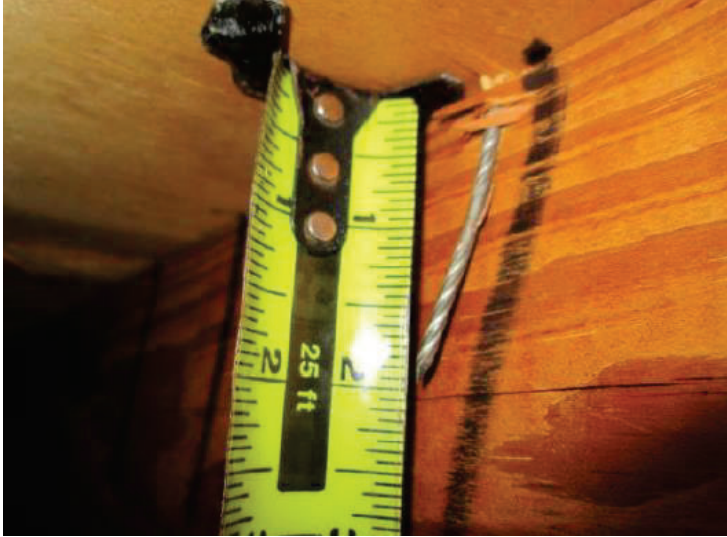
Roof Construction

4. **Roof to Wall Attachment:**        **Clips**  
Comments:                                      Inspection verified hurricane clips fastened with a minimum of three nails.
