COMMERCIAL WINDSTORM MITIGATION REPORT (OIR-B1-1802)

Raintree Village Condominium
2101 Sunset Point Rd, Units 2301-2305
Clearwater, FL 33765

As of 7/1/2020
FPAT File# MUD2014600

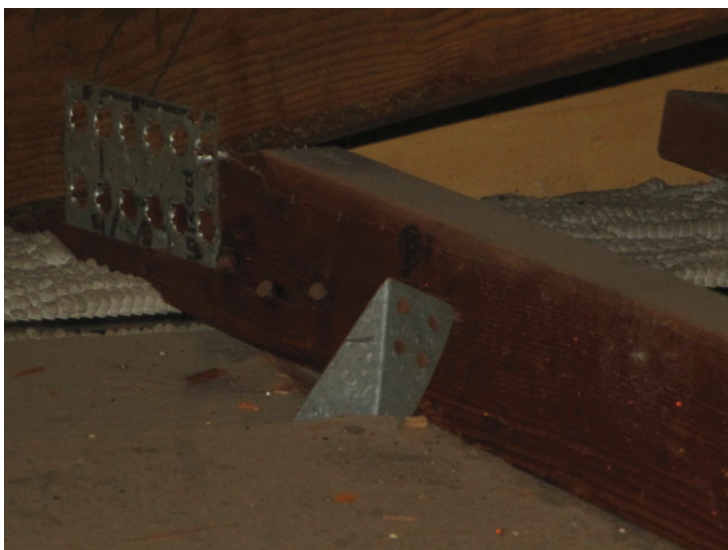
Roof Construction

- 3. Roof Deck Attachment:** **Level C**
Comments: Inspection verified 1/2" plywood roof deck attached with 8d nails at a minimum 6" on the edge & 6" in the field.

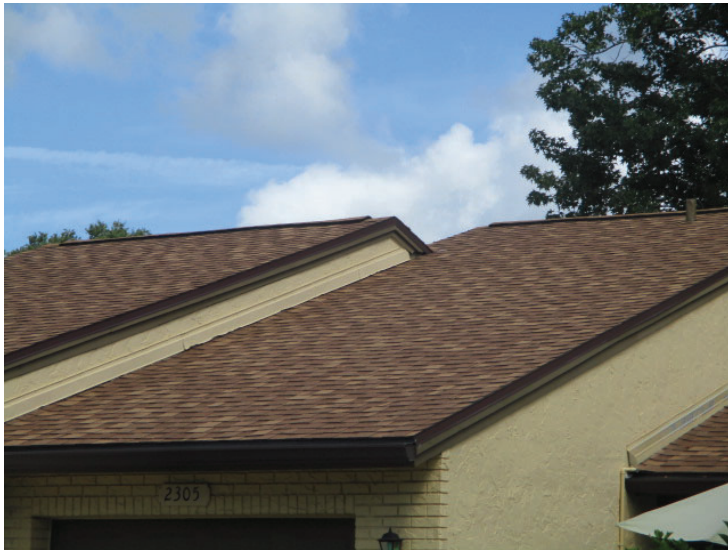
Roof Construction

- 4. Roof to Wall Attachment:** **Clips**
Comments: Inspection verified hurricane clips fastened with a minimum of three nails.
- 5. Roof Geometry:** **Other Roof**
Comments: Inspection verified a gable roof shape.
