COMMERCIAL WINDSTORM MITIGATION REPORT (OIR-B1-1802)

Raintree Village Condominium
2101 Sunset Point Rd, Units 2501-2504
Clearwater, FL 33765

As of 7/1/2020
FPAT File# MUD2014600

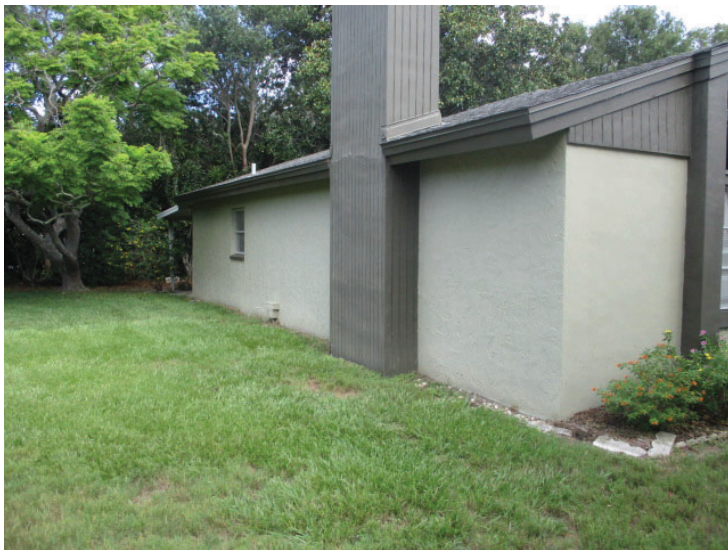
Exterior Elevation

- 4. Roof to Wall Attachment:** **Clips**
Comments: Inspection verified hurricane clips fastened with a minimum of three nails.
- 5. Roof Geometry:** **Other Roof**
Comments: Inspection verified a gable roof shape.

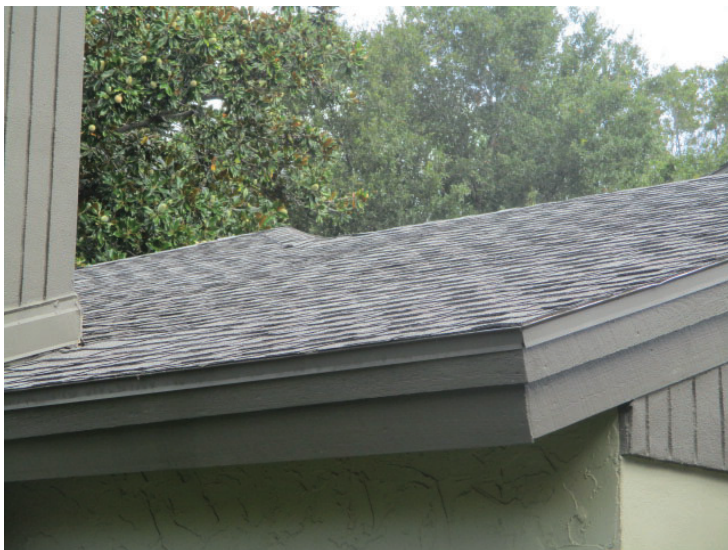
Roof Construction

- 3. Roof Deck Attachment:** **Level C**
Comments: Inspection verified 1/2" plywood roof deck attached with 8d nails at a minimum 6" on the edge & 6" in the field.

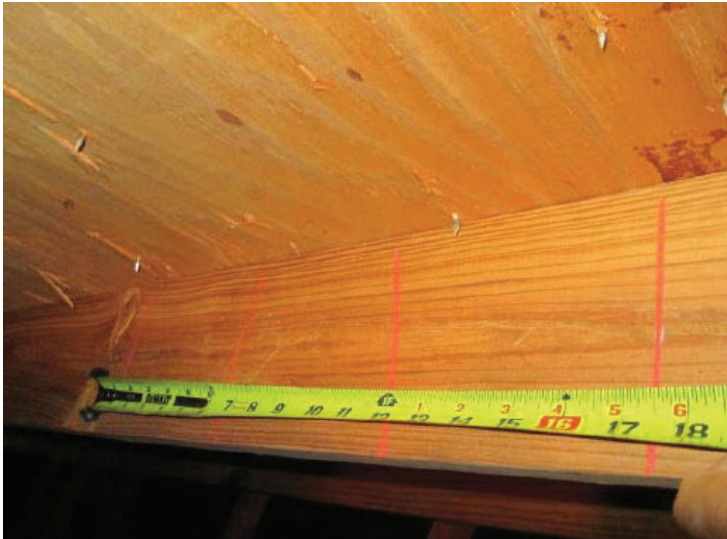
Roof Construction

- 6. SWR:** **Yes**
Comments: SWR was verified at time of inspection. The Secondary Water Resistance verified is a self-adhering peel and stick.
- 7. Opening Protection:** **None or Some Glazed Openings**
Comments: No opening protection verified at the time of inspection.
