## **Windstorm Mitigation Report (OIR-B1-1802)**

Raintree Village Condominium, Inc.  
2101 Sunset Point Rd, Units 2701-2706  
Clearwater, FL 33765

As of 7/1/2020 | FPAT File# MUD2014600

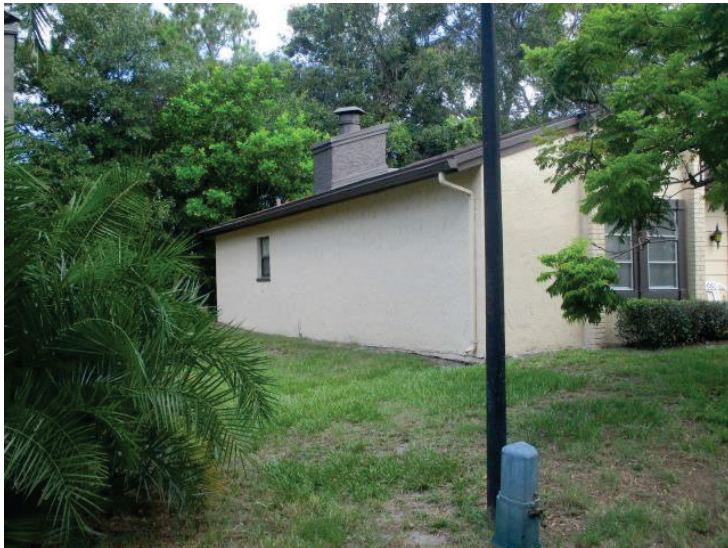
Exterior Elevation

- 4. Roof to Wall Attachment:** **Clips**  
Comments: Inspection verified hurricane clips fastened with a minimum of three nails.
- 5. Roof Geometry:** **Other Roof**  
Comments: Inspection verified a gable roof shape.

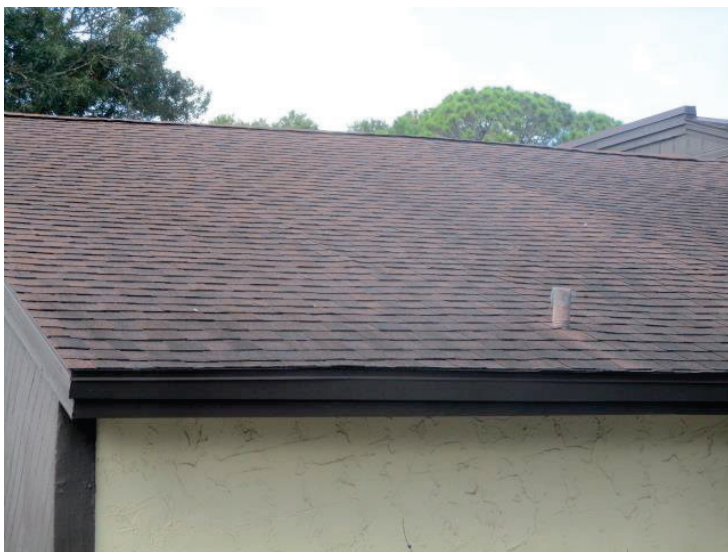
Roof Construction

- 3. Roof Deck Attachment:** **Level C**  
Comments: Inspection verified 1/2" plywood roof deck attached with 8d nails at a minimum 6" on the edge & 6" in the field.
